Vehicle History Report

Chassis number ¹: RP3-1008981

Make: HONDA

Model: STEPWGN SPADA

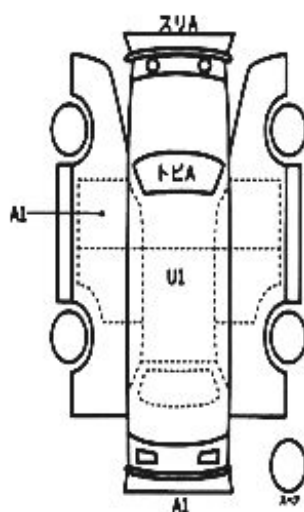
スライドドアコーナー

ルーム内うす汚れ, キズ
