Vehicle History Report

Chassis number ¹: RC1-1032731

Make: HONDA

Model: ODYSSEY

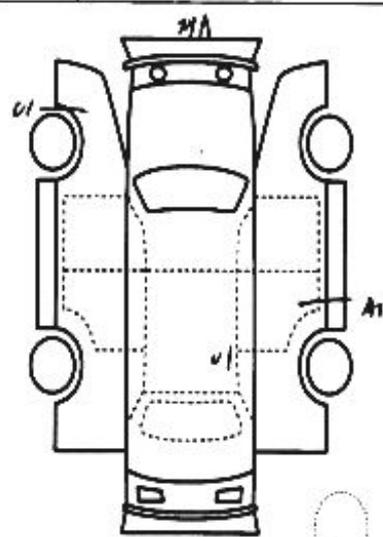
小キズあり
