# Vehicle History Report

**Chassis number <sup>1</sup>:** ANH20-8047112

**Model:** VELLFIRE

**Grade:** 2.4Z

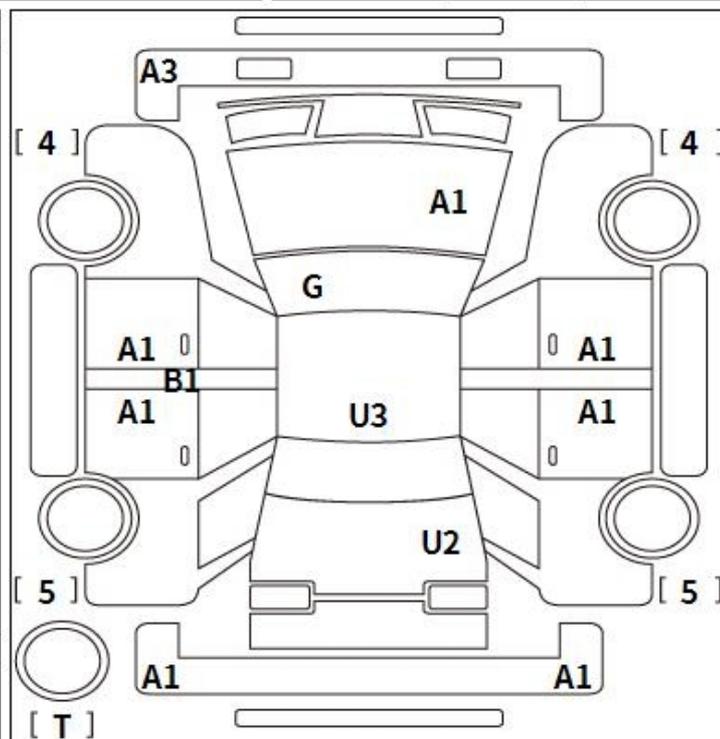
検査員記入欄
コンソール傷 シフトノブすれ ダッシュ板傷 カーペットすれ 室内内張傷 室内汚れ パンパー下A 外装小傷有り
事務局よりご案内

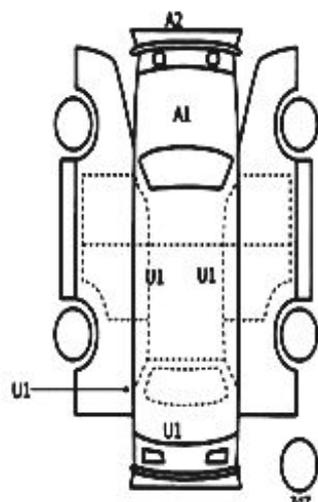
ルーム内うす汚れ、キズ
