Vehicle History Report

Chassis number ¹: RK5-1110518

Make: HONDA

Model: STEPWGN SPADA

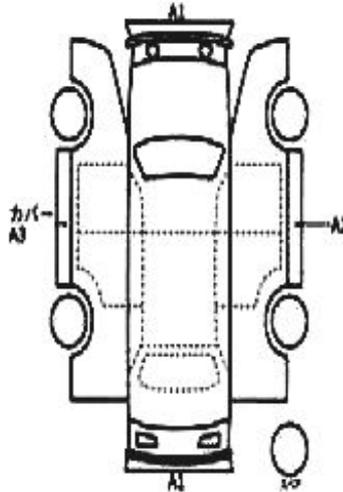
- 検査員補修
- 右電格不良
 - ルーム内汚れキズ
 - ハンドルハゲ
 - 小キズ小凹
