# Vehicle History Report

**Chassis number <sup>1</sup>:** NSP170-7004221

**Model:** SIENTA

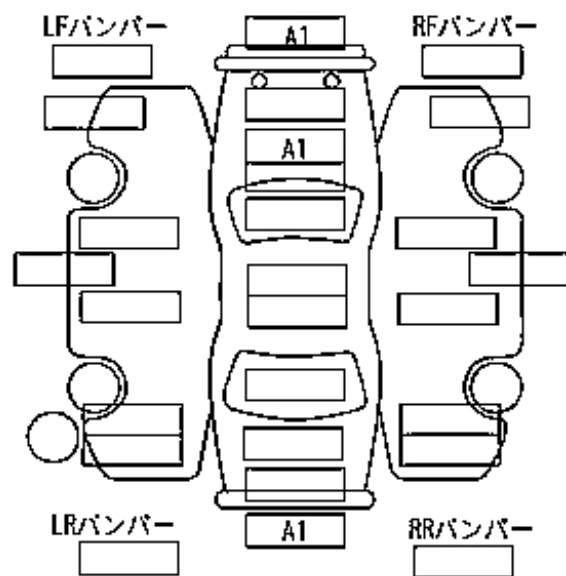
ブッシュスタート  
 バックカメラ  
 ETC  
 両側パワースライドド  
 ア  
 ナビ  
 TV  
 AW  
 レザー調シートカバー  
 8インチリアモニター  
 傷小凹  
 タイヤスタッドレス  
 肉張りうき  
 肉装傷汚れ  
 シートカバー切れ
