# Vehicle History Report

**Chassis number <sup>1</sup>:** RC1-1008411

**Make:** HONDA

**Model:** ODYSSEY

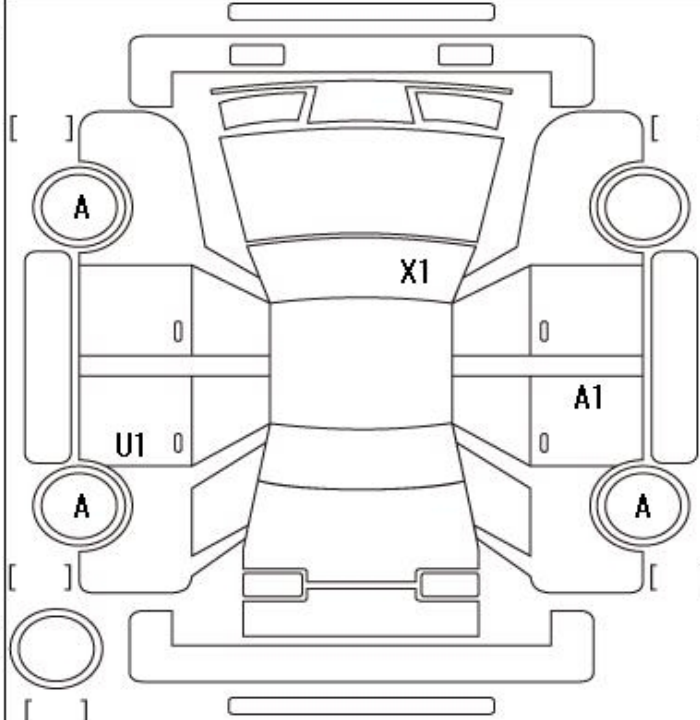
| 検 査 員 記 入 欄 | |
|---|---|
| 外装小傷有り<br>シートしみ小 | |
