# Vehicle History Report

**Chassis number <sup>1</sup>:** Z12-208419

**Make:** NISSAN

**Model:** CUBE

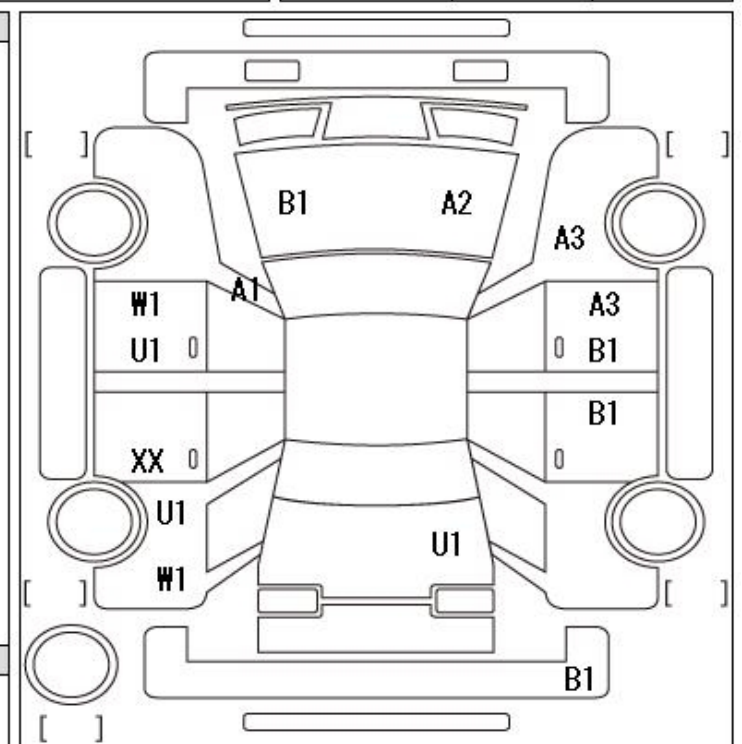
検査員記入欄
室内汚れ 荷室傷 ホイールカバーA 外装うすい線傷、しみ
事務局よりご案内 売切リスタート 部品預り
