VEHICLE DETAILS

Chassis number ¹: Z12-110772

Make: NISSAN

Model: CUBE

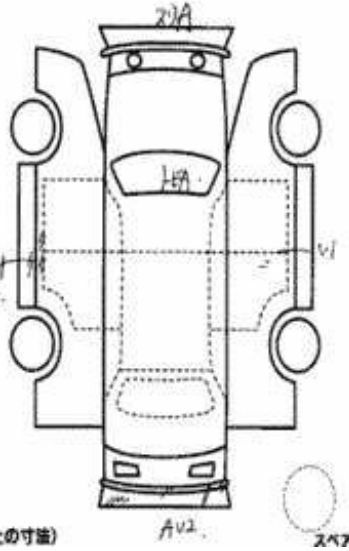
51579	車歴 (自家用以外は記入)	排気量	型式	評価点
		1500	DBA-Z12	
	初年度登録年月	車名	グレード	4.5
	22/8月	キズ-7	5D 15X MCV 4WD	内装 B
車検	29年8月	シフト	SR 純AW	PS (PW)
走行	68674 km	CAT	カワ TV ナビ	エアB
外色	白	カラー	セールスポイント	
内装	L50	冷房	*ナビ付! *HDDナビ! *7速!	
燃料	ガソリン	有/無	*ナビ付! *HDDナビ! *7速!	
輸入車	輸入区分	ハンドル	*ナビ付! *HDDナビ! *7速!	
	ディーラー・並行	左・右	*ナビ付! *HDDナビ! *7速!	
リサイクル	9820円	乗車定員	登録年	531
		5人	車台	Z12-110772
注意事項 (※不具合箇所および状態等)		シリアル
