## VEHICLE DETAILS

**Chassis number <sup>1</sup>:** WVVZZZ6RZBY311707

**Make:** VOLKSWAGEN

**Model:** POLO

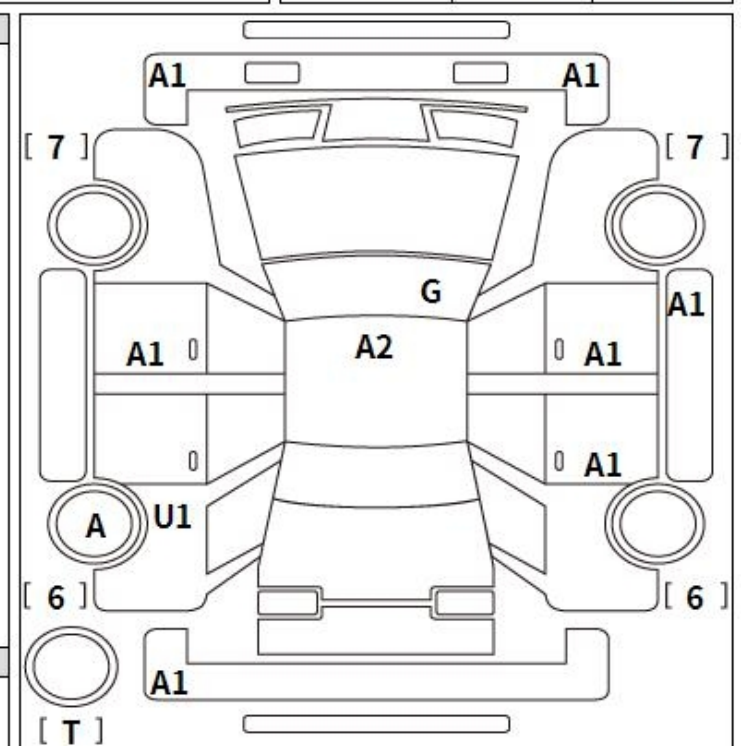
| ABS・スリップ表示灯点灯<br>空気圧警告灯点灯<br>シート切れ・破れ小<br>室内動物の毛<br>ダッシュ板のり付<br>タッチP跡<br>バンパー下A<br>ガラスフィルム張 |
