# Vehicle History Report

**Chassis number <sup>1</sup>:** RB3-1118652

**Make:** HONDA

**Model:** ODYSSEY

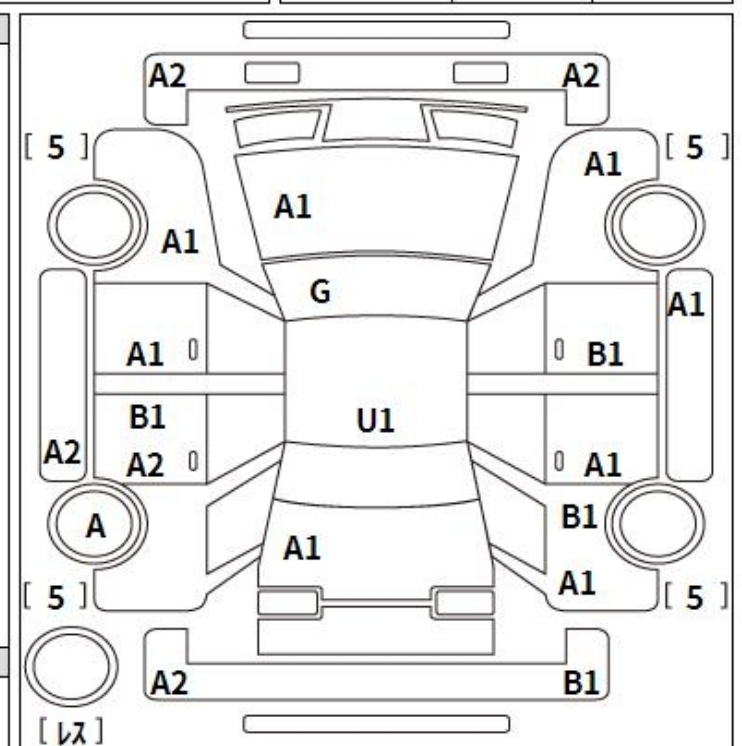
検査員記入欄
外装うすい線キズ 下廻りAU 室内内張傷 シートしわ 室内汚れ
事務局よりご案内
キーケース ★埼玉サテライト★埼玉県幸手市
