Vehicle History Report

Chassis number ¹: WVVZZZ1KZBW281164

Make: VOLKSWAGEN

Model: GOLF

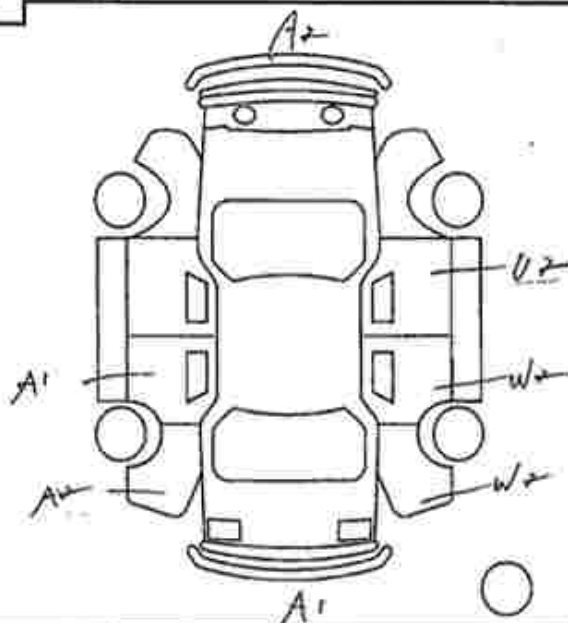
[1884]
60044

キーロック
X
ホイール・CPPカスフレ / ドアミラー(キズワレ)
小キズ有 / 小リ傷 / 捕撮有
