# Vehicle History Report

**Chassis number <sup>1</sup>:** RB3-1010297

**Make:** HONDA

**Model:** ODYSSEY

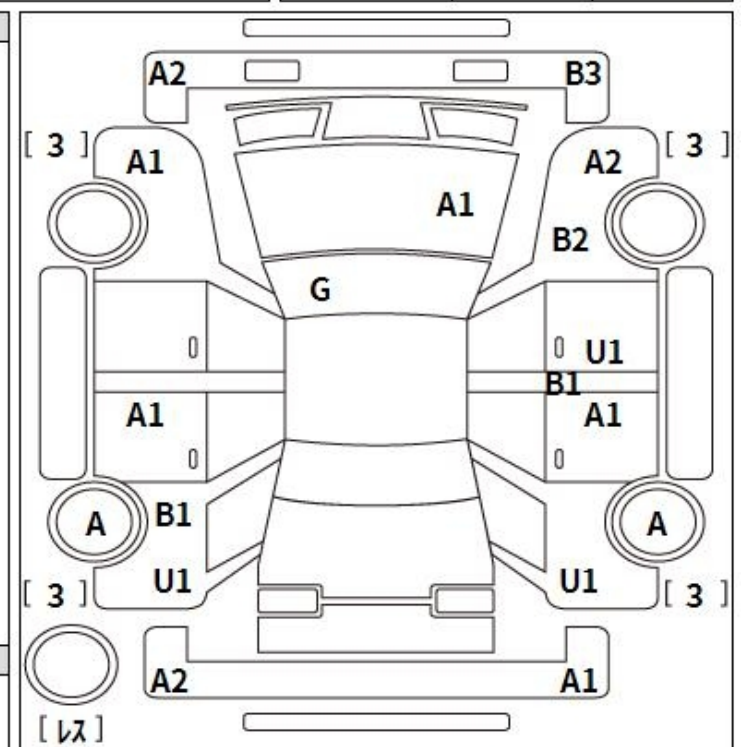
検査員記入欄
<p>★★愛媛サテライト会場出品車★★  Fインナー小U  外装しみ  エンジン廻りオイル漏れ  シートしわ  シートへたり  シート汚れ  ミラーA  外装小傷有り</p>
事務局よりご案内
<p>四国エリア外会員様落札は西日本輸送センター手配です  ※本社所在地が四国エリア外の会員様落札対象</p>
