# Vehicle History Report

**Chassis number <sup>1</sup>:** PE52-000318

**Make:** NISSAN

**Model:** ELGRAND

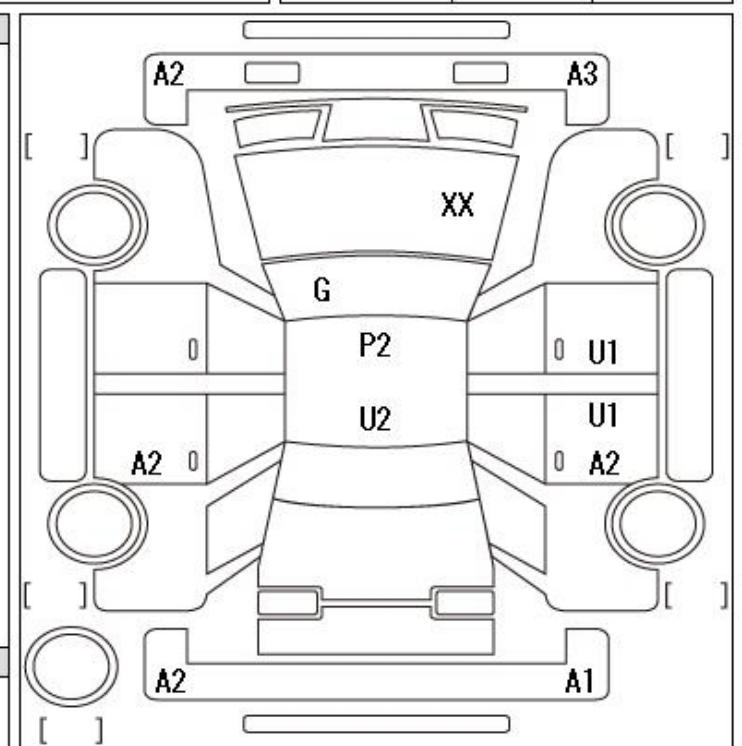
出品番号	初度登録	車名	ドア形状	グレード	評価点
11002 初出品	H22年	エルグランド	5W	ライダー 黒本革シート パワシート	4
	10月	車歴 自家用	排気量 3500 cc	燃料 ガソリン	型式 DBA-PE52
					外装 内装 C D

検査員記入欄
<p>ダッシュボード切れ・破れ シート切れ・破れ小 ハンドルすれ エアロ下A 外装小傷有り 外ハンドル、足廻り</p>
事務局よりご案内

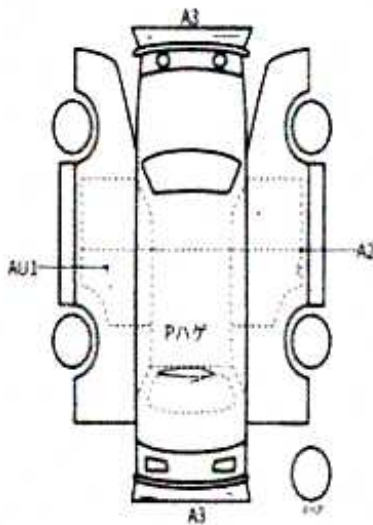
17972	車種 (自家用以外は記入)	排気量	型式	4
		3500	DBA-PE52	
初年度登録年月日	車名	グレード	駆動	C
H22/10月	エルブランド	5D ライダー	2WD

- 検査員報告
- ダッシュ板フレ
  - ルーム内一部汚れ
  - ホイールキズ, センターCP1 個欠
  - Dミラーキズ
  - 小キズ小凹
