Vehicle History Report

Chassis number ¹: RR1-1302174

Make: HONDA

Model: ELYSION

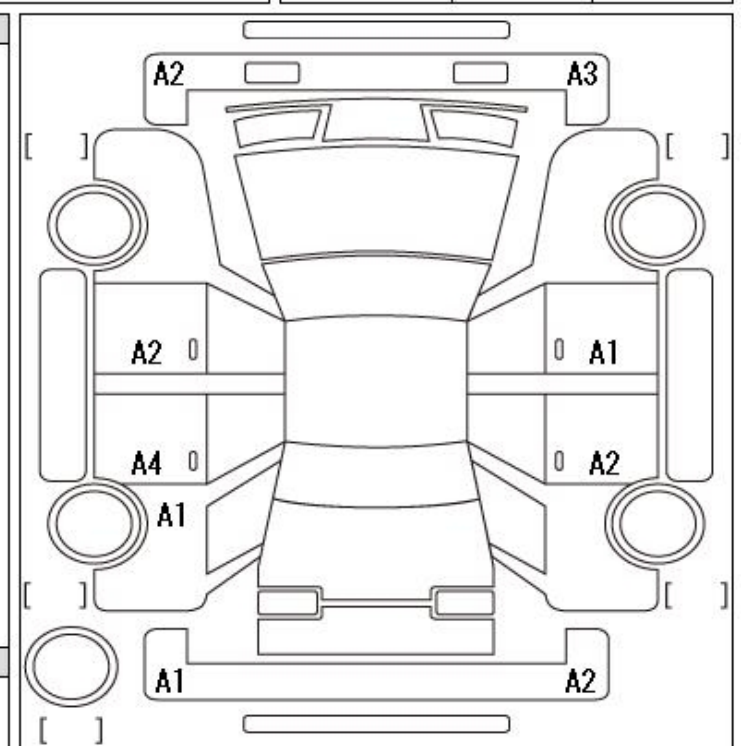
検査員記入欄
室内汚れ 外装うすい線傷、しみ バンパー下A
事務局よりご案内
売切リスタート
