# Vehicle History Report

Chassis number <sup>1</sup>: TE52-054462

Model: ELGRAND

Grade: 250 HIGHWAY STAR

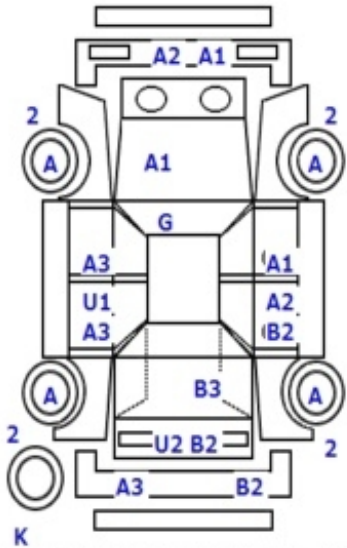
総合評価	外装評価	内装評価
3.5	D	D

トランクフロア小凹み

シート 汚れ

シート 切れ・破れ小

天張 汚れ

天張 キズ

ドア内張 スレ小

ダッシュ板 ワレ

車内 汚れ

ハンドル キズ

外装小A・小凹

下廻り サビ

ラゲッジ部凹
