Vehicle History Report

Chassis number ¹: ANH20-8139311

Model: VELLFIRE

Grade: 2.4Z PLATINUM SELECTION II

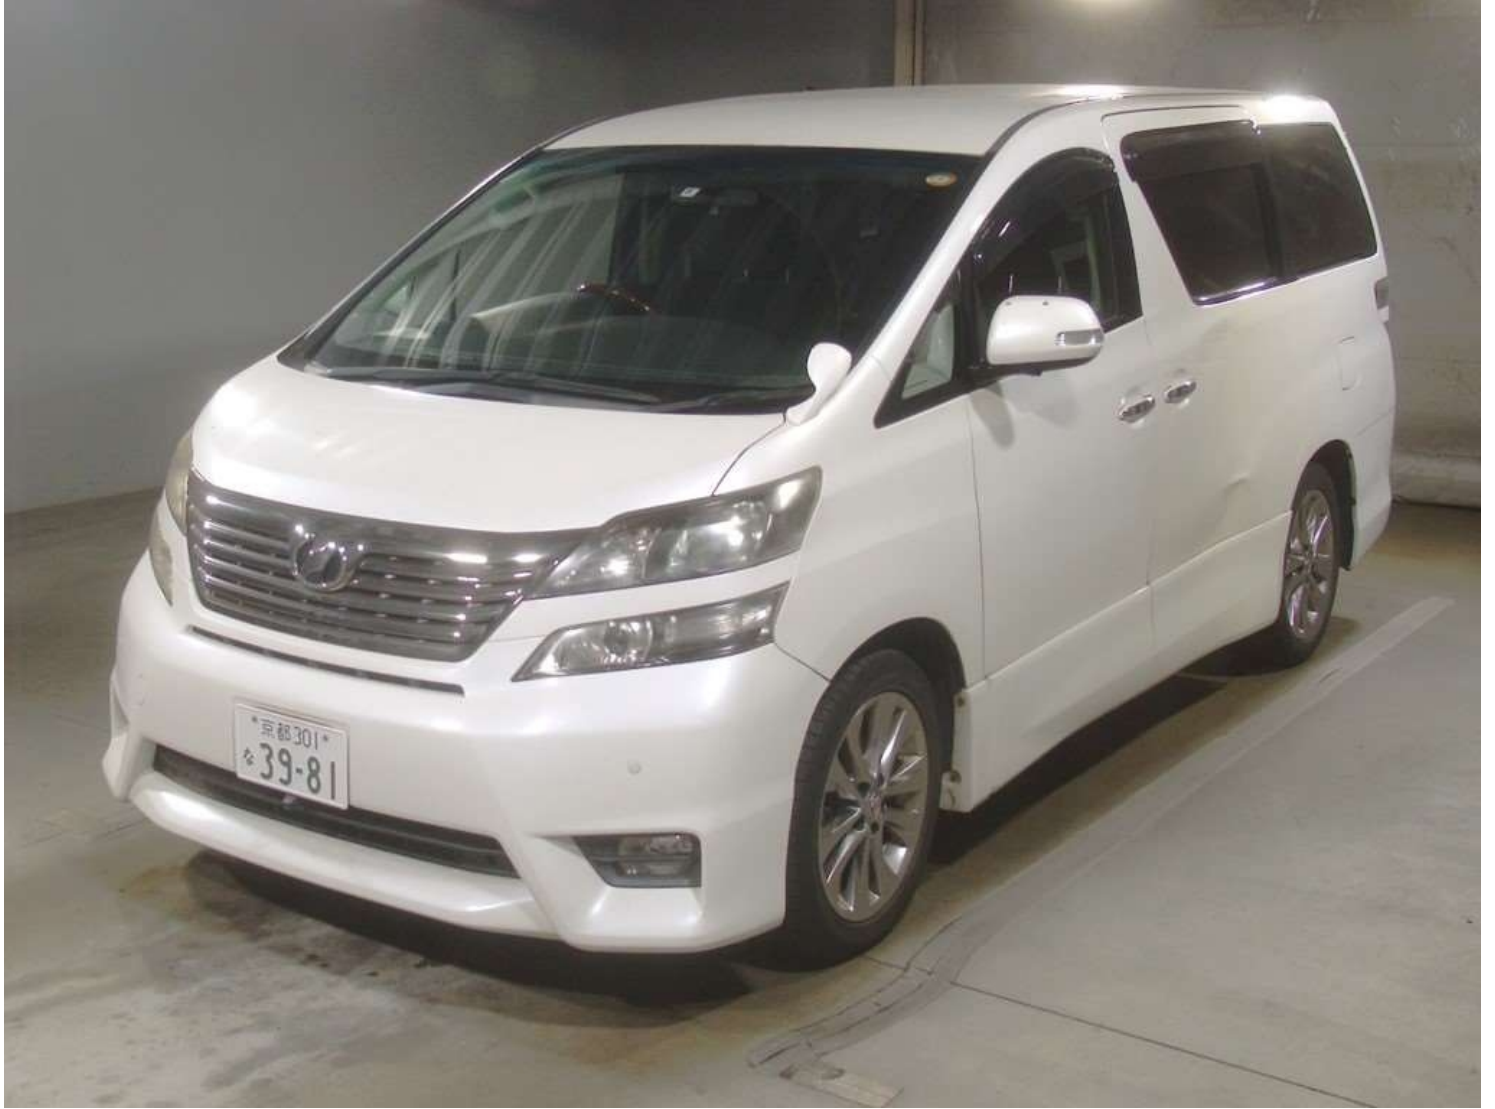
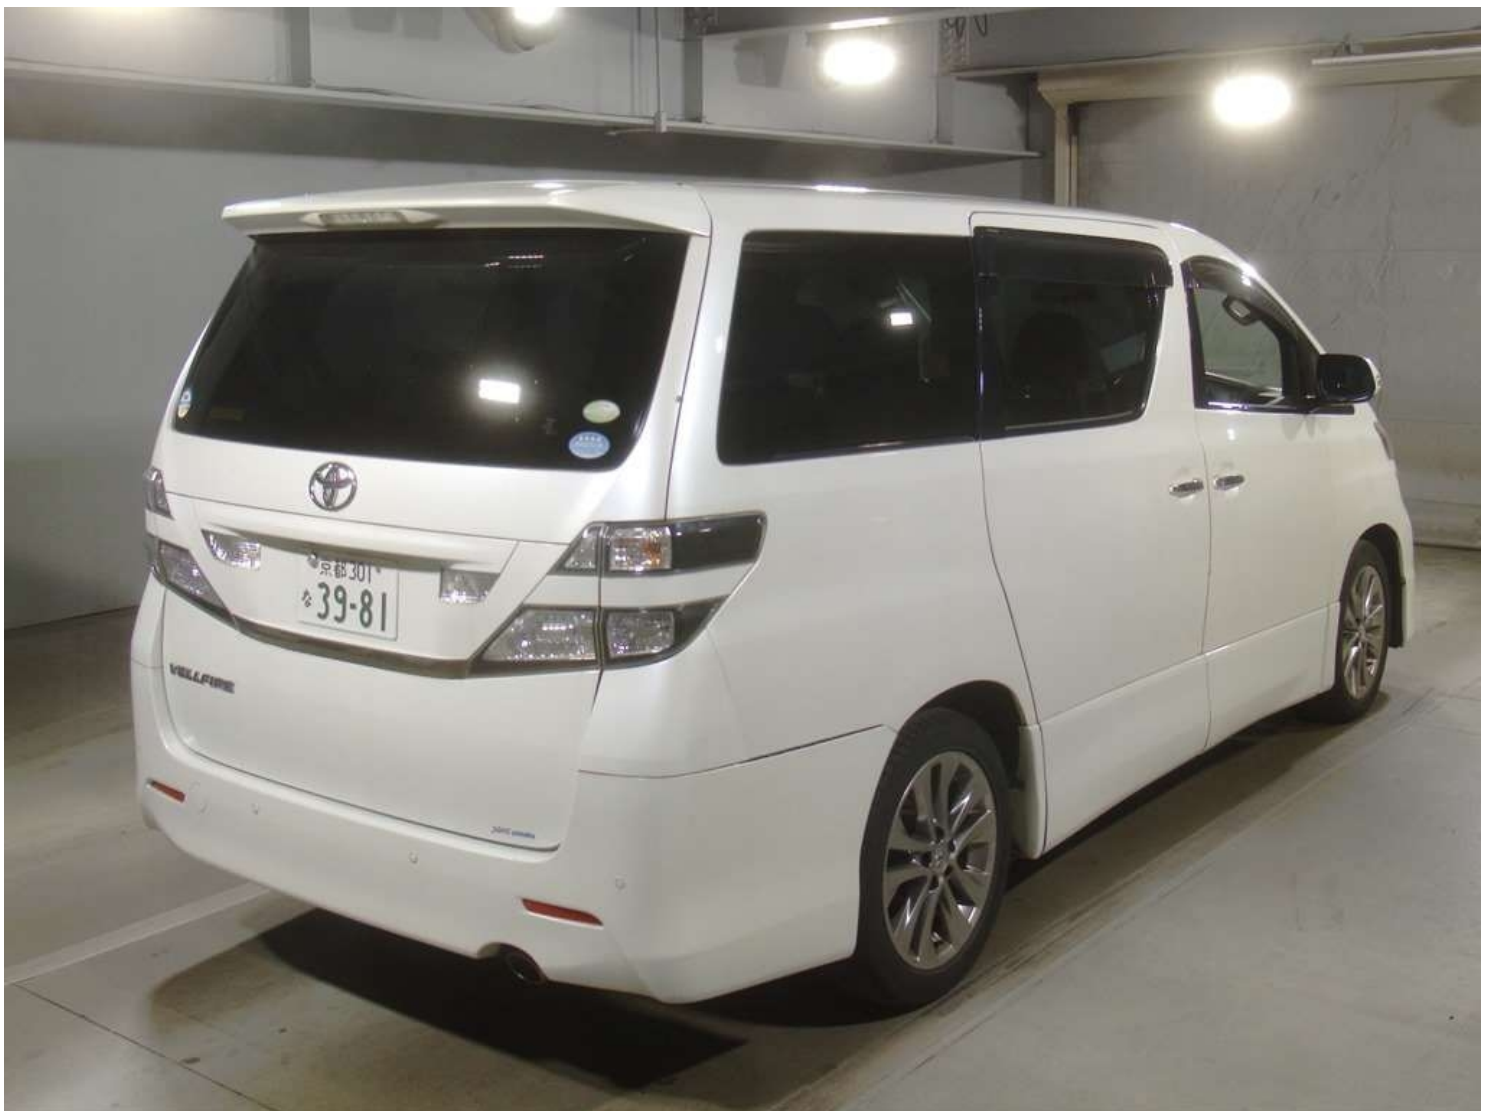
静岡フレッシュコーナー

35148	車種 (自動車以外は記入)	排気量	型式	年式
		2400	DBA-ANH20W	3.5
	初年度登録年月	車名	グレード	2WD
	22/8月	ヴェルファイア	2.4Z	4WD
		5	ナビ付	
車検	5年	8月	シフト	AT
走行	61,578 Km	冷房	WAC	セールスポイント
外色	シルバー	カラー	070	ナビ付・ETC
内色	ベージュ	内装		両側ナビ・サイド
燃料	ガソリン	駆動方式		ナビ・ナビ付
登録料	18290円	乗車定員	7人	登録地
注	18290	7		愛知
				車台
				8139511
				シリアル

検査員報告 (USS使用欄)
 ルーム内1年済
 山手

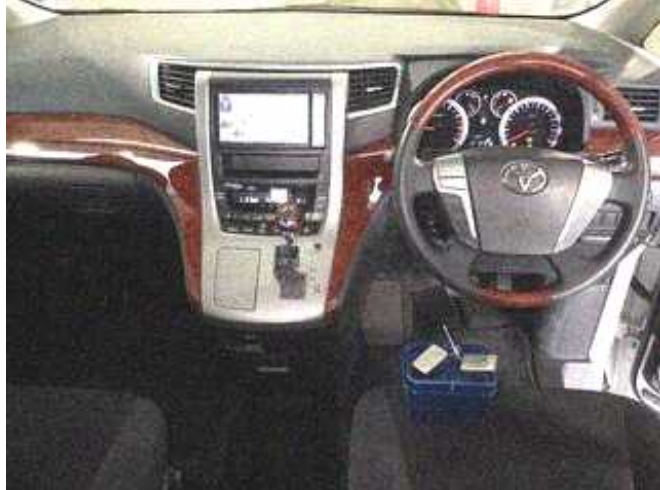
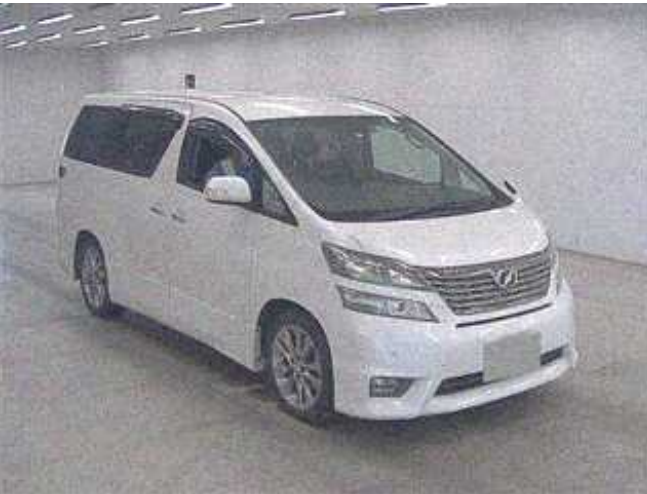
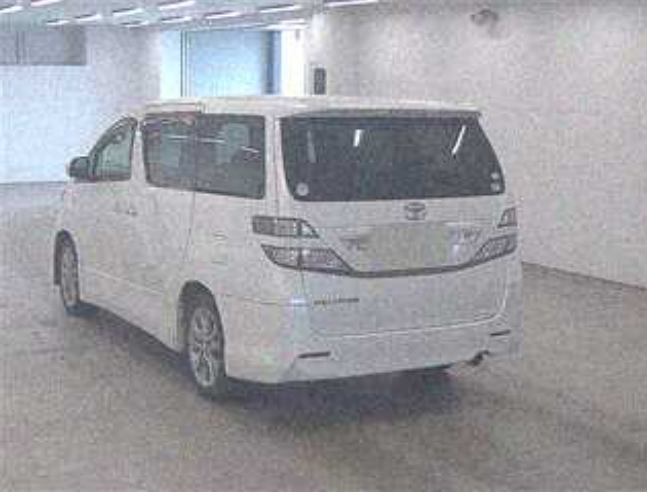
MIRIVE 出品票

初度登録	車名	ドア	グレード	駆動	評価点
H22 8	ヴェルファイア	5	2.4Zプラチナセレクション2	2WD 4WD	4
年 月	型式	排気量	保証年	定員	
2010	DBA - ANH20W	2,400	有・無	7	
年	CC				
走行	車種	色 (Col.No)	燃料	外装	内装
98791 <small>マイル</small> <small>km</small>	7 7	パール 070	◎・D・電気 (その他)	C	C
シフト	エアコン	リサイクル預託金	純正装備品		
IAT	AAC	18,290	PS PW AW	エア ABS 革 SR	ナビ DTN
<注意事項>		登録簿有効期限	<セールスポイント>		
★ユーザー買取★車検R.7年7月迄★		月 日	★フルセグ付純正HDDナビ★DVD再生可★スマートキー★		
		輸入車	★バックガイド&サイド&ブラインドコーナーモニター★		
		ディーラー・銀行	★両側パワースライドドア★純正18インチAW★		
		左H・右H	★クリアランスソナー★革巻コンピステアリング★		
			★HIDヘッドライト★ウインカーミラー★フォグ★		
			★オートライト★6エアバッグ★ビルトインETC★		
<検査員記入欄>			キーロック		
Fガラス (キズ・飛石・ヒビ・リペア跡・X要)					
内装 (キズ・ヒビ・シミ・コゲ・穴・キレ・破れ・割れ)					
オーディオ (無し・穴) / タイヤ (スタッドレス)					
エレクトロニクス					
ダッシュ板バグ		スマートキー車内	ホイル・CP ウレノドアミラー スワレ 小キズ等 小リ傷 補修有		
登録	①	②	③/④	⑤	⑥
ナンバー	スペアキー	キーレス	スマート	登録番号	販売番号
				なにわ 301り3813	ANH20-8139311

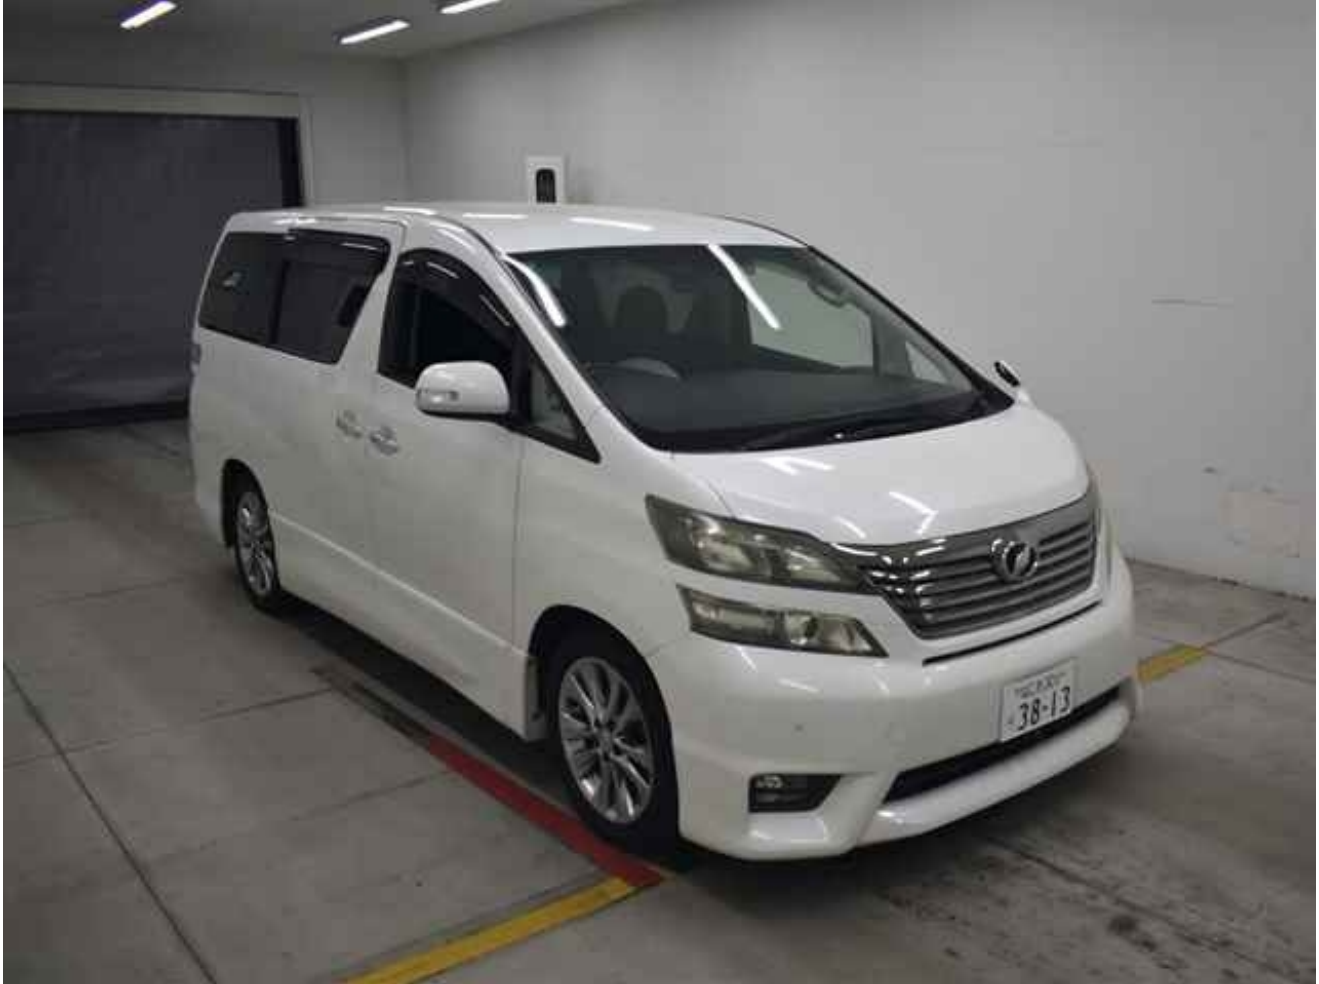
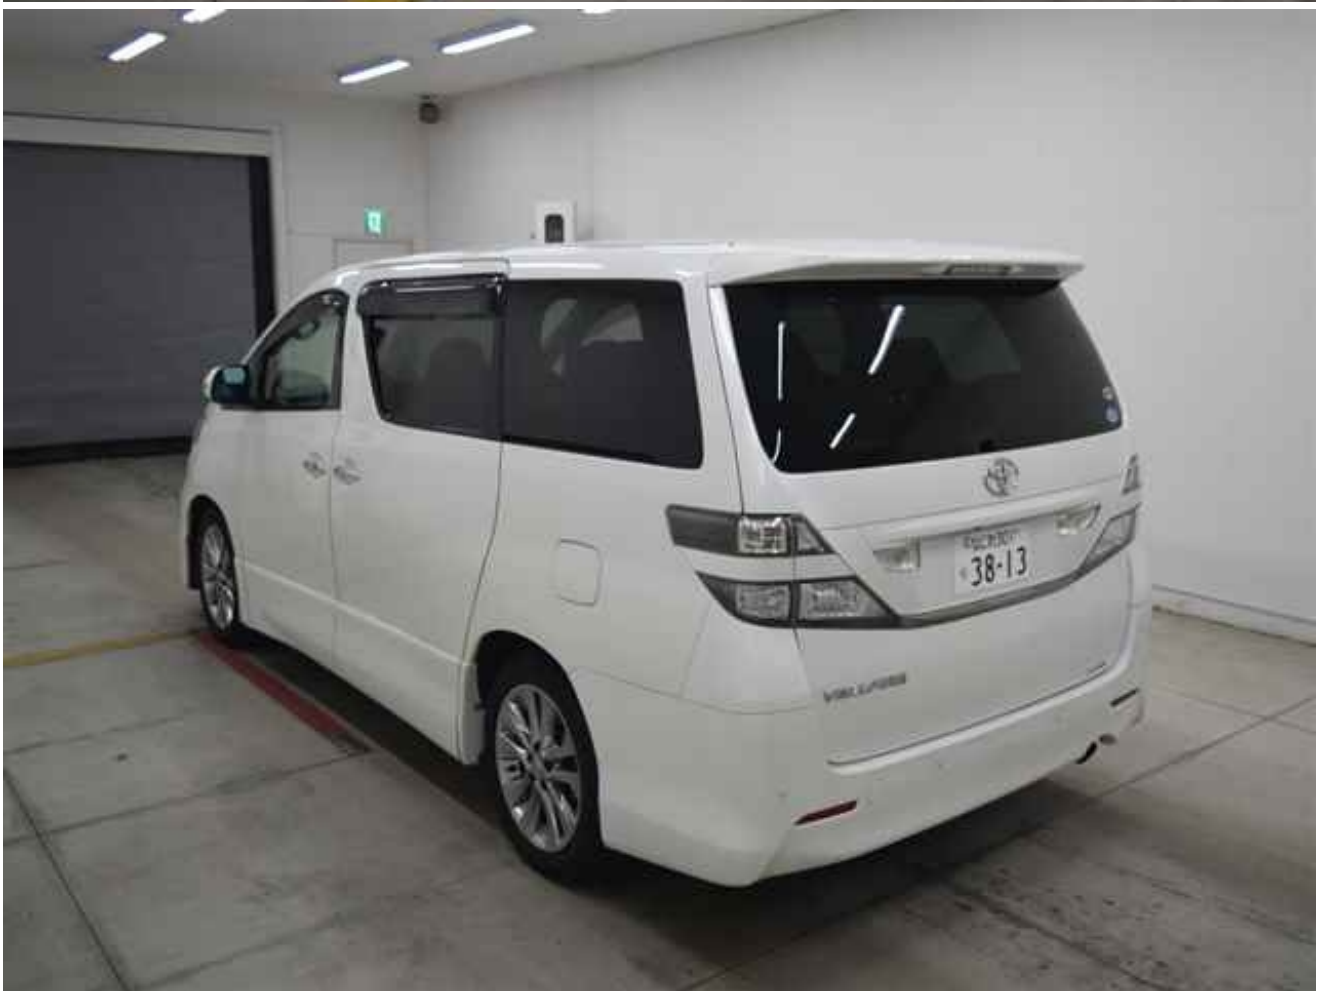
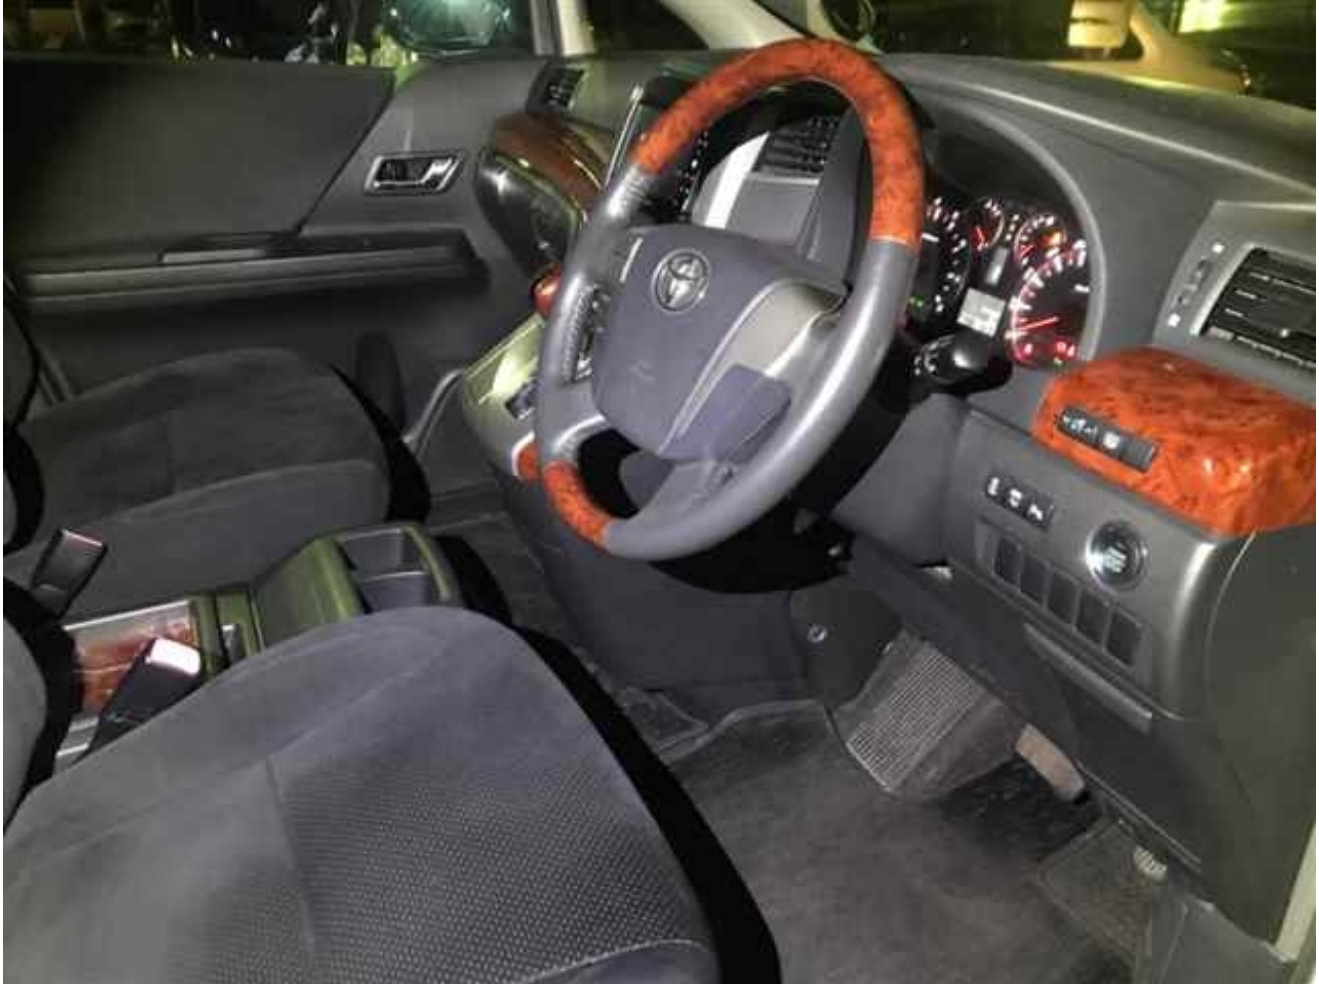
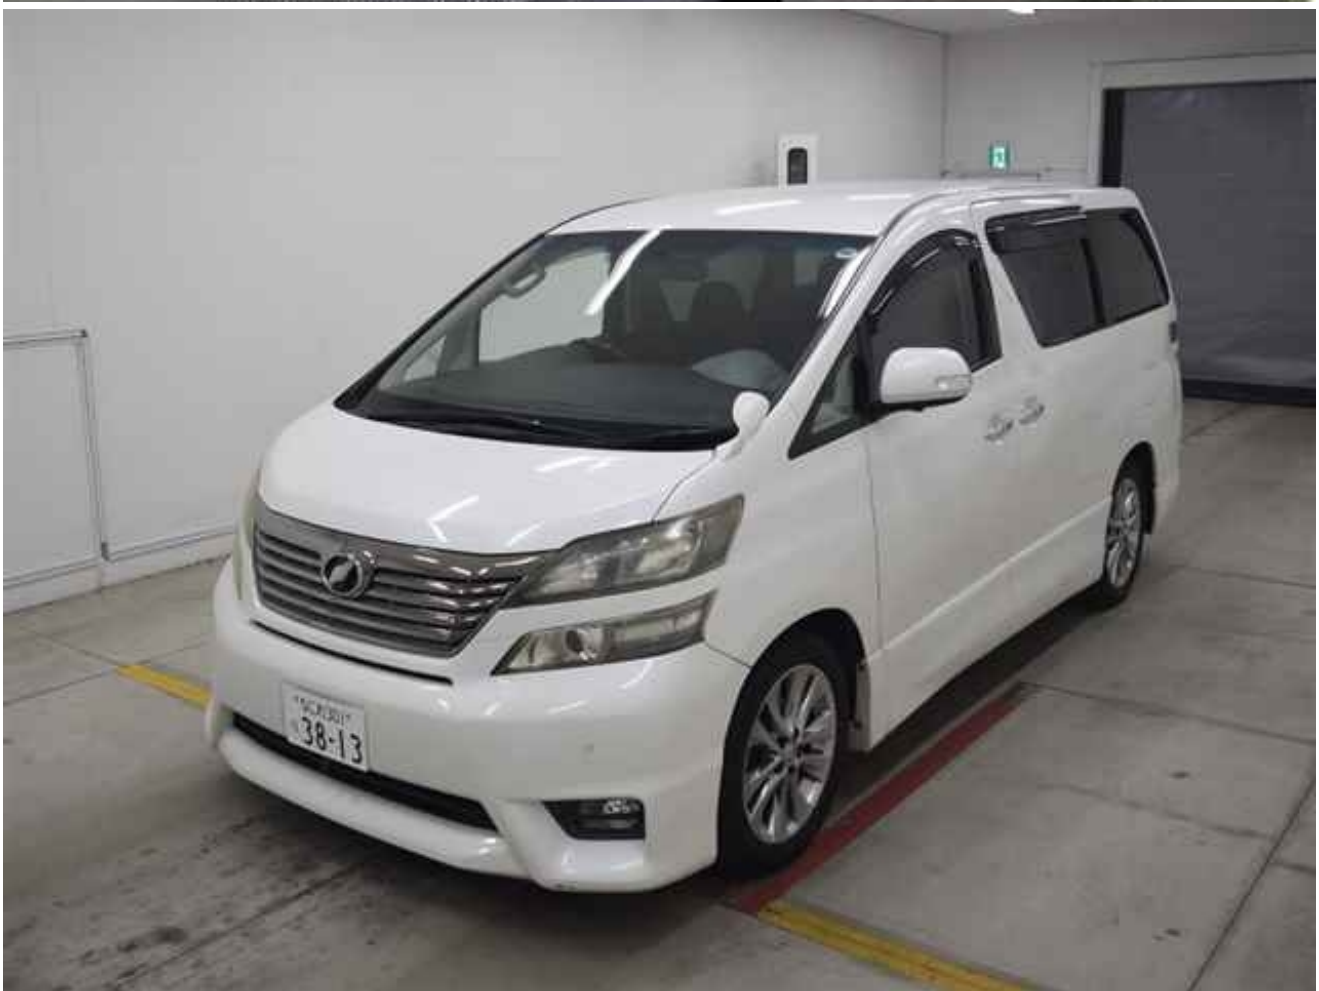
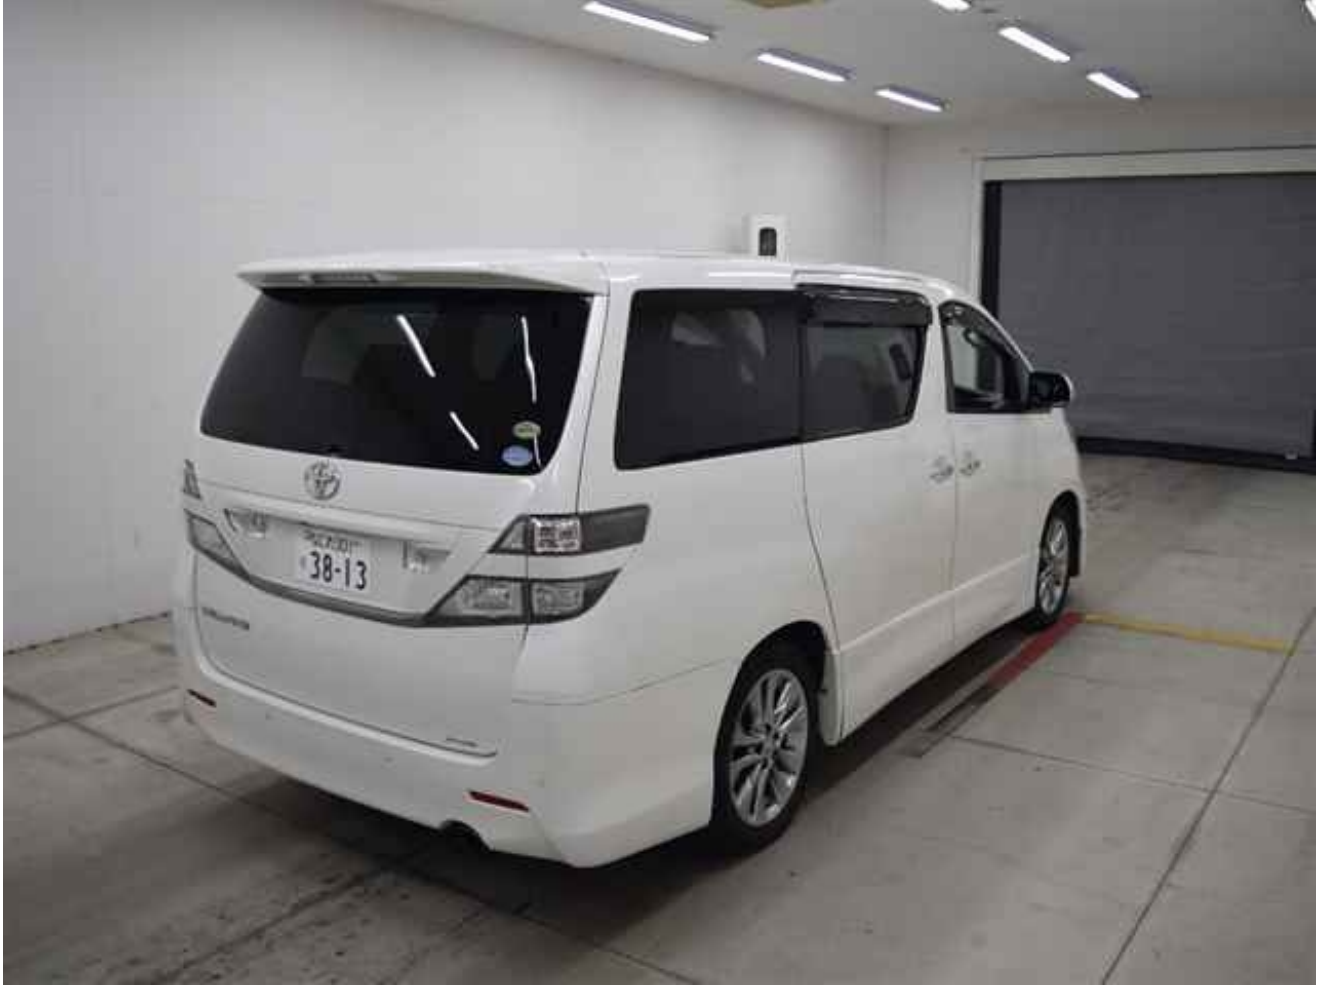
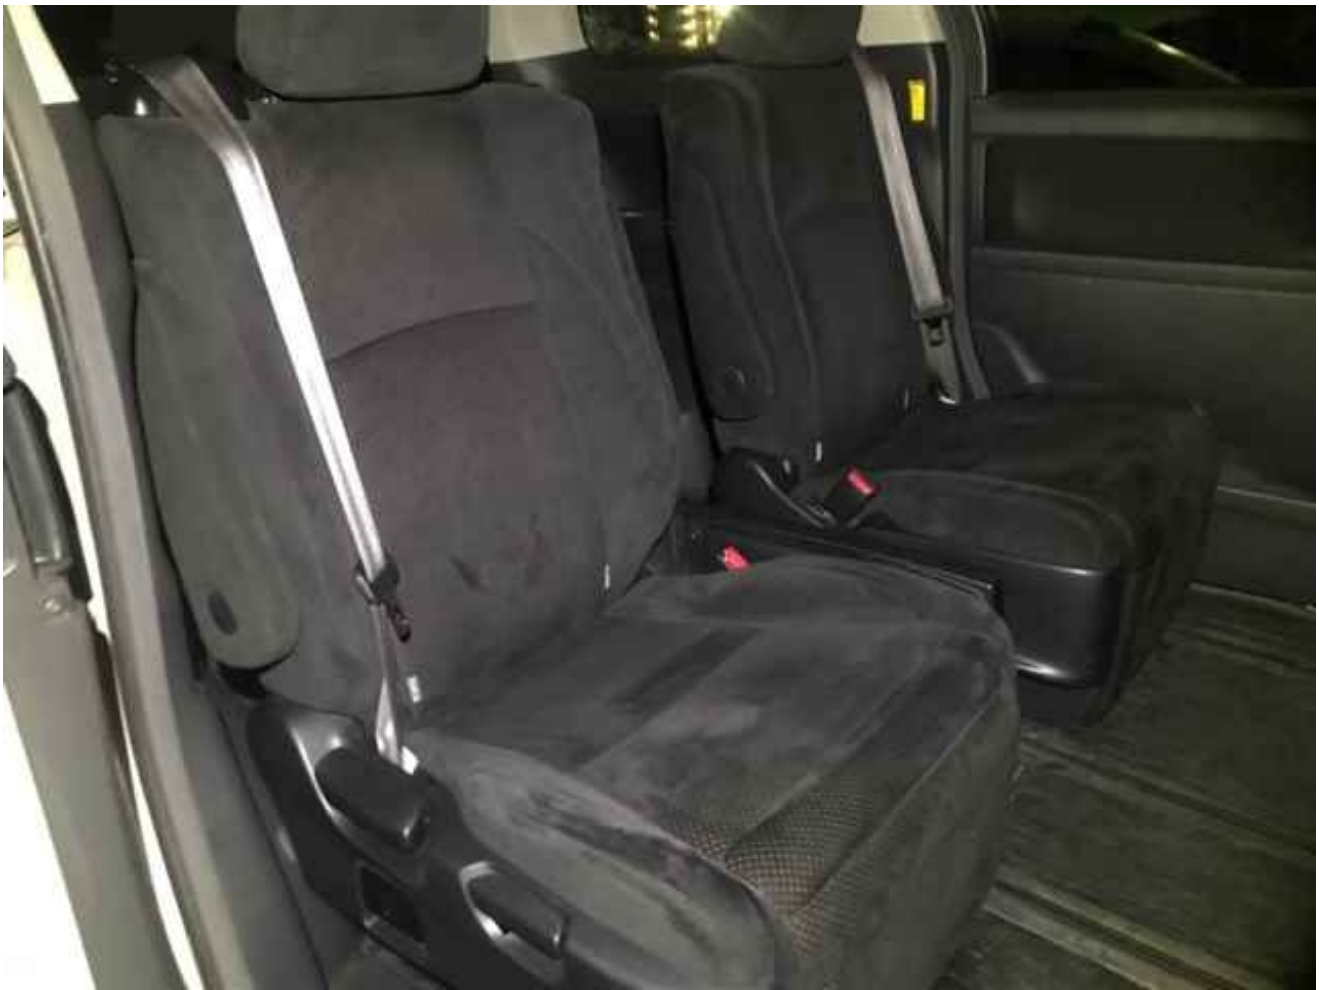
整理No.	44901086	車名	トヨタ ヴェルファイア 2.4ZプラチナSel2																																																													
型式	DBA-ANH20W	車台番号	ANH20-8139311	走行距離	98,850 Km <small>※交換がある場合の 交換時距離</small>																																																											
外装	<input checked="" type="checkbox"/> キズ <input checked="" type="checkbox"/> 凹み <input checked="" type="checkbox"/> 割れ <input checked="" type="checkbox"/> 塗装・板金 <input checked="" type="checkbox"/> サビ <input checked="" type="checkbox"/> 交換 <input checked="" type="checkbox"/> その他 <input checked="" type="checkbox"/> 総合/3.5 <input checked="" type="checkbox"/> 外装/3.5 <input checked="" type="checkbox"/> 内装/B				修復歴 有 <input checked="" type="checkbox"/> <small>※マイルは Km 表示</small>																																																											
ダメージ	小 大																																																															
		<table border="1"> <thead> <tr> <th>No.</th> <th>箇所</th> <th>コメント</th> </tr> </thead> <tbody> <tr> <td>1</td> <td>右前ドアパネル</td> <td>キズ 小</td> </tr> <tr> <td>2</td> <td>右フェンダー</td> <td>キズ 小</td> </tr> <tr> <td>3</td> <td>前バンパー</td> <td>キズ 中</td> </tr> <tr> <td>4</td> <td>前バンパー</td> <td>キズ 中・TP2・バンパーズレ</td> </tr> <tr> <td>5</td> <td>左後ドアパネル</td> <td>キズ 中</td> </tr> <tr> <td>6</td> <td>後バンパー</td> <td>キズ 中</td> </tr> <tr> <td>7</td> <td>後バンパー</td> <td>ひび割れ 中・バンパー右ズレ</td> </tr> <tr> <td>8</td> <td>右後ドア</td> <td>キズ 小・S1</td> </tr> <tr> <td>9</td> <td>右後ドアパネル</td> <td>キズ 中・TP2</td> </tr> <tr> <td>10</td> <td>その他</td> <td>ヘッドライト・もりドアミラー・外装 小</td> </tr> </tbody> </table>			No.	箇所	コメント	1	右前ドアパネル	キズ 小	2	右フェンダー	キズ 小	3	前バンパー	キズ 中	4	前バンパー	キズ 中・TP2・バンパーズレ	5	左後ドアパネル	キズ 中	6	後バンパー	キズ 中	7	後バンパー	ひび割れ 中・バンパー右ズレ	8	右後ドア	キズ 小・S1	9	右後ドアパネル	キズ 中・TP2	10	その他	ヘッドライト・もりドアミラー・外装 小	<p>交修曲凹 換正りみ</p> <table border="1"> <tr> <td><input checked="" type="checkbox"/></td> <td>①フレーム</td> </tr> <tr> <td><input checked="" type="checkbox"/></td> <td>②クロスメンバー</td> </tr> <tr> <td><input checked="" type="checkbox"/></td> <td>③インナー</td> </tr> <tr> <td><input checked="" type="checkbox"/></td> <td>④ピラー(A・B・C・D)</td> </tr> <tr> <td><input checked="" type="checkbox"/></td> <td>⑤ダッシュパネル</td> </tr> <tr> <td><input checked="" type="checkbox"/></td> <td>⑥ルーフパネル</td> </tr> <tr> <td><input checked="" type="checkbox"/></td> <td>⑦フロアパネル</td> </tr> <tr> <td><input checked="" type="checkbox"/></td> <td>⑧トランクフロアパネル</td> </tr> <tr> <td><input checked="" type="checkbox"/></td> <td>⑨サイドステップ</td> </tr> <tr> <td><input checked="" type="checkbox"/></td> <td>⑩リアインナー</td> </tr> <tr> <td><input checked="" type="checkbox"/></td> <td>⑪コアサポート</td> </tr> <tr> <td><input checked="" type="checkbox"/></td> <td>⑫バックパネル</td> </tr> <tr> <td><input checked="" type="checkbox"/></td> <td>⑬リアクォーター</td> </tr> </table> <p>※ の箇所は修復歴の対象にはなりません。</p>	<input checked="" type="checkbox"/>	①フレーム	<input checked="" type="checkbox"/>	②クロスメンバー	<input checked="" type="checkbox"/>	③インナー	<input checked="" type="checkbox"/>	④ピラー(A・B・C・D)	<input checked="" type="checkbox"/>	⑤ダッシュパネル	<input checked="" type="checkbox"/>	⑥ルーフパネル	<input checked="" type="checkbox"/>	⑦フロアパネル	<input checked="" type="checkbox"/>	⑧トランクフロアパネル	<input checked="" type="checkbox"/>	⑨サイドステップ	<input checked="" type="checkbox"/>	⑩リアインナー	<input checked="" type="checkbox"/>	⑪コアサポート	<input checked="" type="checkbox"/>	⑫バックパネル	<input checked="" type="checkbox"/>	⑬リアクォーター

No.	箇所	コメント																																																														
1	右前ドアパネル	キズ 小																																																														
2	右フェンダー	キズ 小																																																														
3	前バンパー	キズ 中																																																														
4	前バンパー	キズ 中・TP2・バンパーズレ																																																														
5	左後ドアパネル	キズ 中																																																														
6	後バンパー	キズ 中																																																														
7	後バンパー	ひび割れ 中・バンパー右ズレ																																																														
8	右後ドア	キズ 小・S1																																																														
9	右後ドアパネル	キズ 中・TP2																																																														
10	その他	ヘッドライト・もりドアミラー・外装 小																																																														
<input checked="" type="checkbox"/>	①フレーム

<input checked="" type="checkbox"/>	⑪コアサポート																																																															
<input checked="" type="checkbox"/>	⑫バックパネル																																																															
<input checked="" type="checkbox"/>	⑬リアクォーター																																																															
※中古車の為、目立たない小キズ・ウスキズは表記しておりませんが御了承下さい。		リサイクル券 18,290円																																																														
保証書：有 <input checked="" type="checkbox"/> 記録簿：有 <input checked="" type="checkbox"/> 外装色：[070] 真珠白 内装色：黒 タイヤサイズ： F 235/50R18 R 235/50R18	備考 フルセグ付純正HDDナビ、DVD再生可、バックガイド&サイド&ブラインドコーナーモニター 両側パワースライドドア、純正18インチAW、ディスチャージ、ウインカーミラー、パワーバックドア クリアランスソナー、コンピステアリング、6エアバック、オートライト、スマートキー、ビルトインETC																																																															
<table border="1"> <thead> <tr> <th>内装</th> <th>機関係</th> <th>駆動系</th> <th>足廻り</th> <th>電装系</th> </tr> </thead> <tbody> <tr> <td>ダッシュボードキズ</td> <td></td> <td>F F</td> <td></td> <td> A/C <input checked="" type="checkbox"/> NG 無 P/S <input checked="" type="checkbox"/> NG 無 F/W <input checked="" type="checkbox"/> NG 無 </td> </tr> </tbody> </table>	内装	機関係	駆動系	足廻り	電装系	ダッシュボードキズ		F F		A/C <input checked="" type="checkbox"/> NG 無 P/S <input checked="" type="checkbox"/> NG 無 F/W <input checked="" type="checkbox"/> NG 無

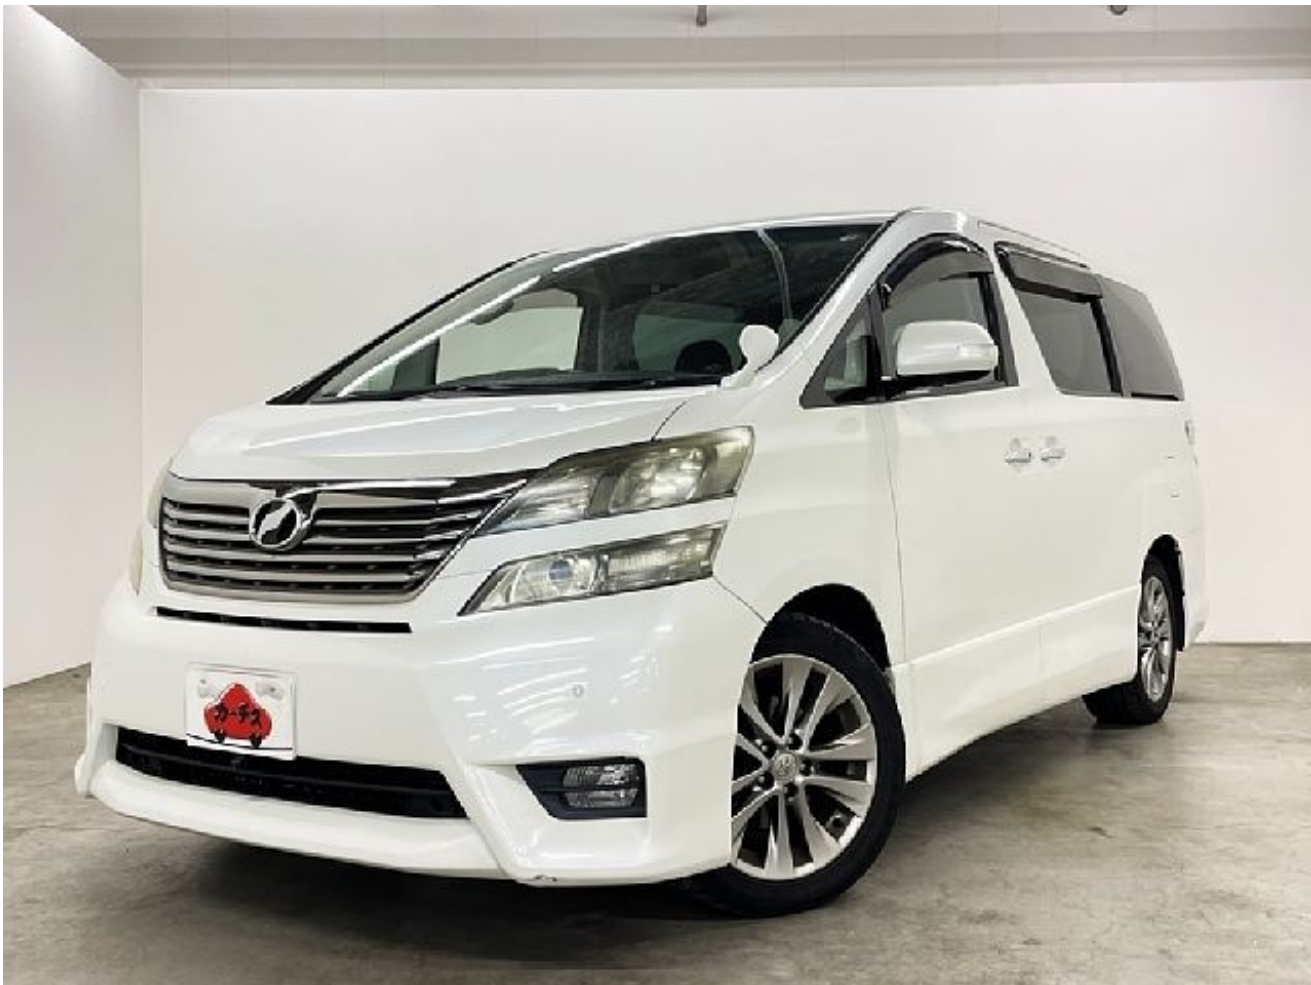
<input checked="" type="checkbox"/>	②クロスメンバー																																																															
<input checked="" type="checkbox"/>	③インナー																																																															
<input checked="" type="checkbox"/>	④ピラー(A・B・C・D)																																																															
<input checked="" type="checkbox"/>	⑤ダッシュパネル																																																															
<input checked="" type="checkbox"/>	⑥ルーフパネル																																																															
<input checked="" type="checkbox"/>	⑦フロアパネル																																																															
<input checked="" type="checkbox"/>	⑧トランクフロアパネル																																																															
<input checked="" type="checkbox"/>	⑨サイドステップ																																																															
<input checked="" type="checkbox"/>	⑩リアインナー
