Vehicle History Report

Chassis number ¹: RC1-1010081

Make: HONDA

Model: ODYSSEY

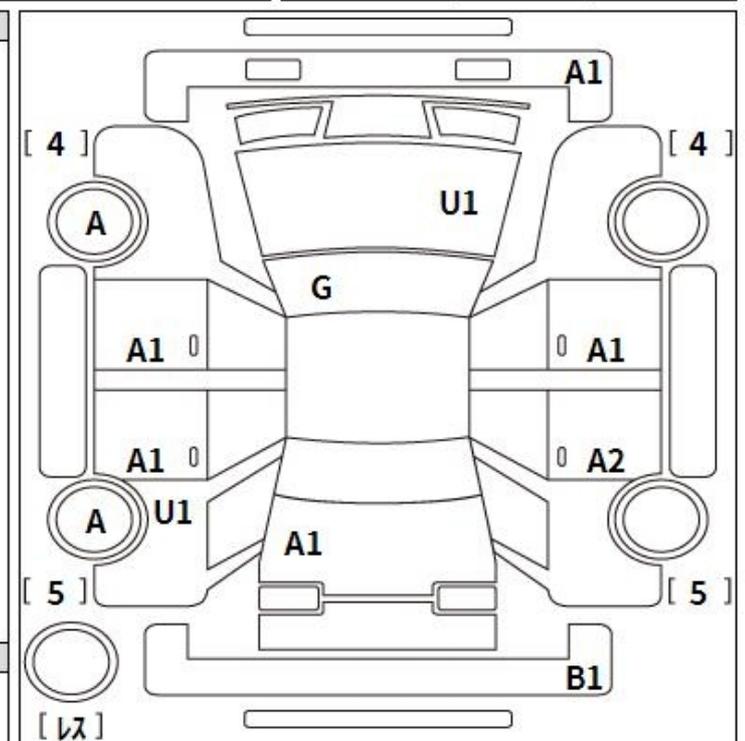
検査員記入欄
エンジン廻りオイル漏れ 外装小傷多い 下廻りAU 室内内張傷 ミラーA
事務局よりご案内
★★静岡サテライト会場出品車★★

A:外^レ U:外^レ B:外^レを伴う外^レ P:要塗装 W:補修跡 S:錆 C:腐食 G:70点外^レ5点外^レ XX:交換済み X:要交換 内・外装評価 5段階評価(A・B・C・D・E) 2

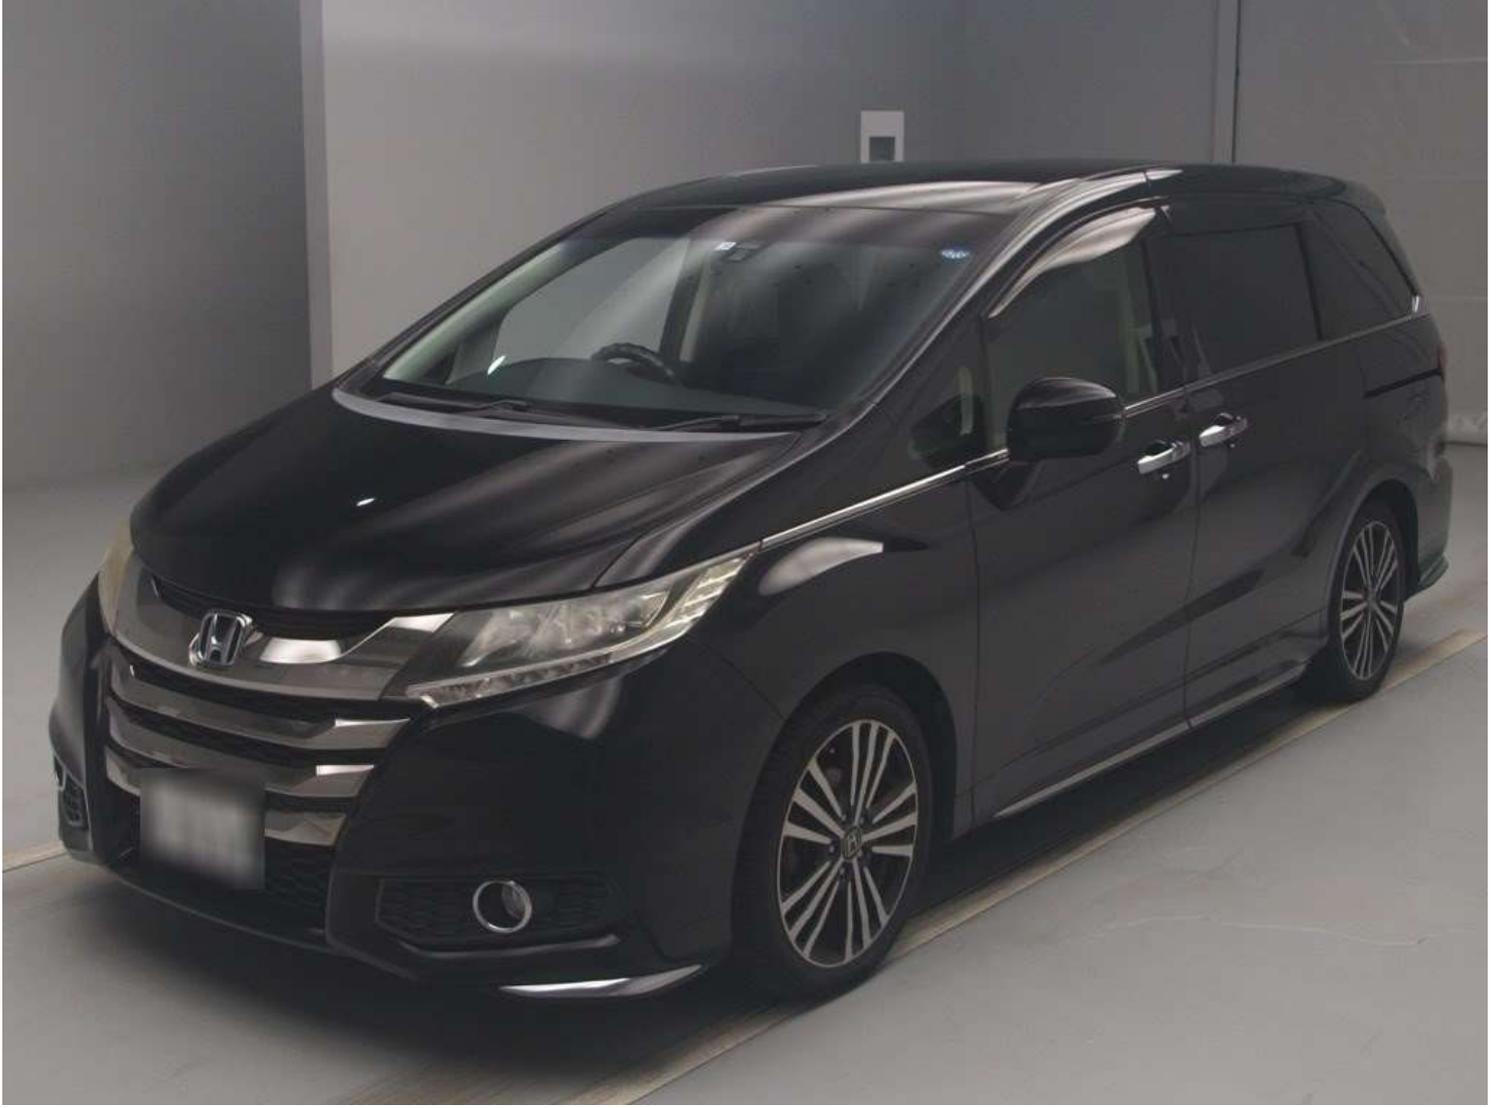
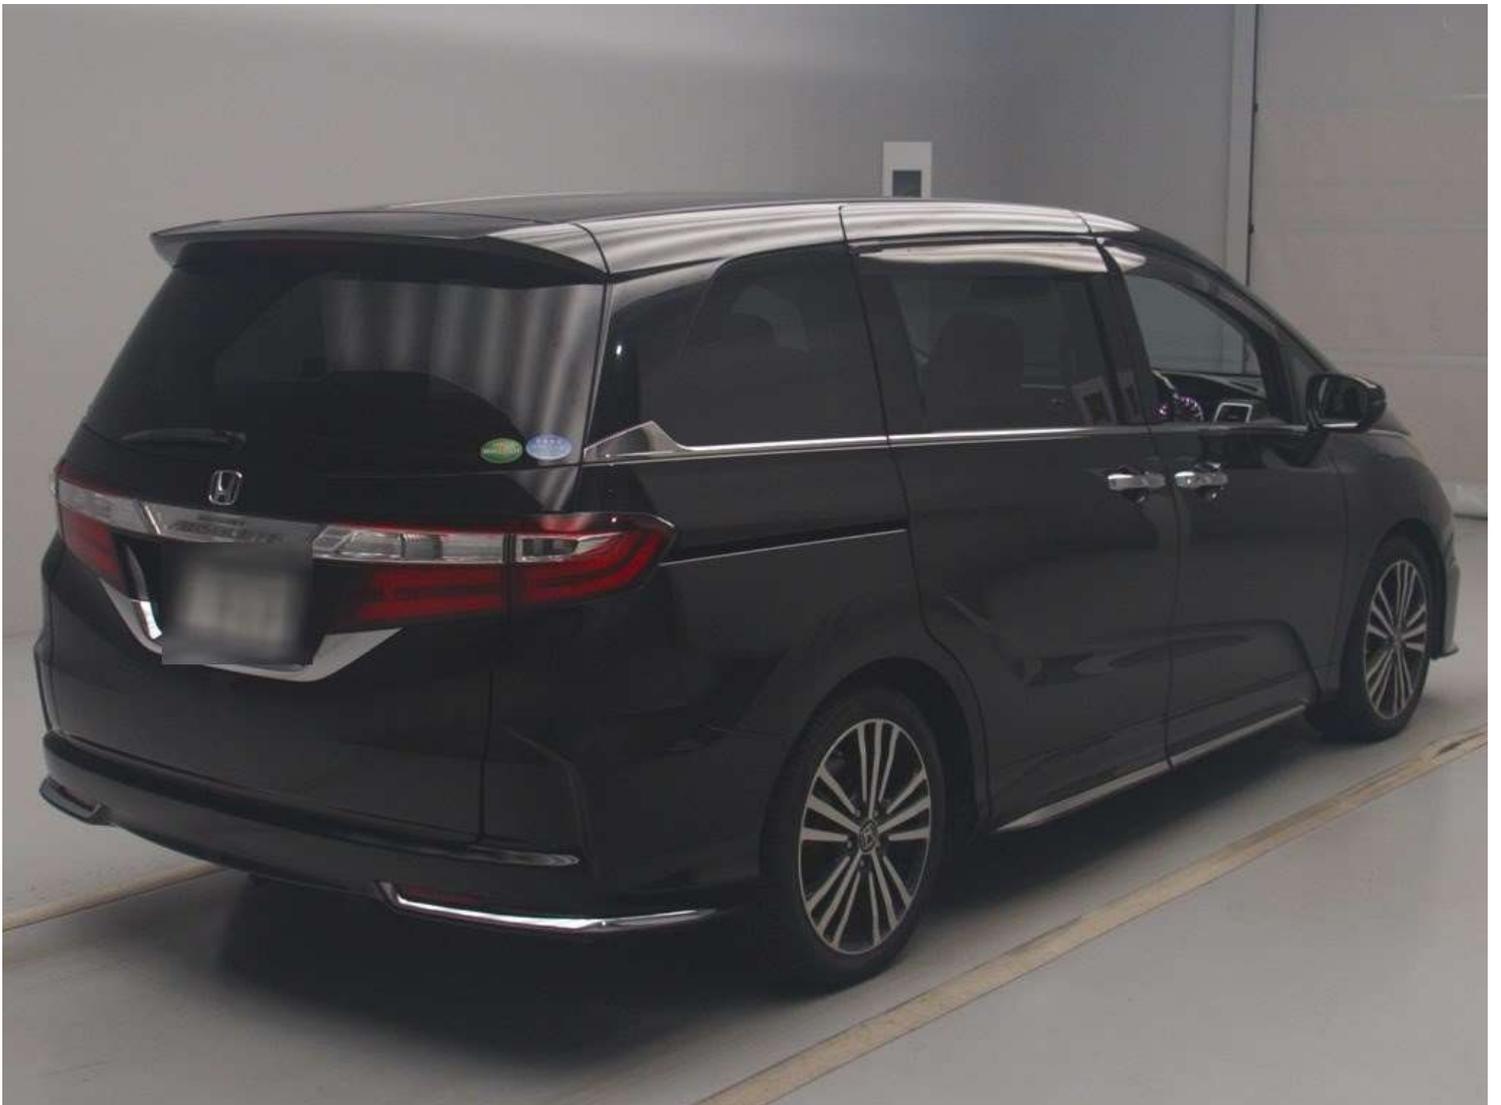
45151	車種 (自家用以外は記入)	排気量	型式	評価点 4.5
	自家用	2400	DBA-RC1	
	初年度登録年月	車名	グレード	2WD
	25/12月	アソビ	5 アソビ	4WD
車検		6年 12月	シフト	AT
走行	92,530 km	冷房	AAC	
外色	70	色	カラー	販売ポイント
内色		色	NH711P	PUSHスタート
燃料	ガソリン	駆動方式	有・無	
輸入車種		輸入区分	ハンドル	
	ディーラー	並行	左・右	月 日
リサイクル料	14420円	検査定員	7人	登録No
検査料				301 13 4254
○注意事項 (検査 不具合箇所および状態等)				車台No
				RC1-1010081
				シリアルNo

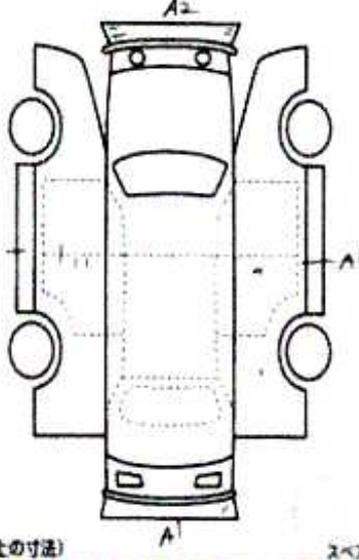
○検査員報告 (USS使用欄)

ル・ム内取一部汚れ
取付カマ

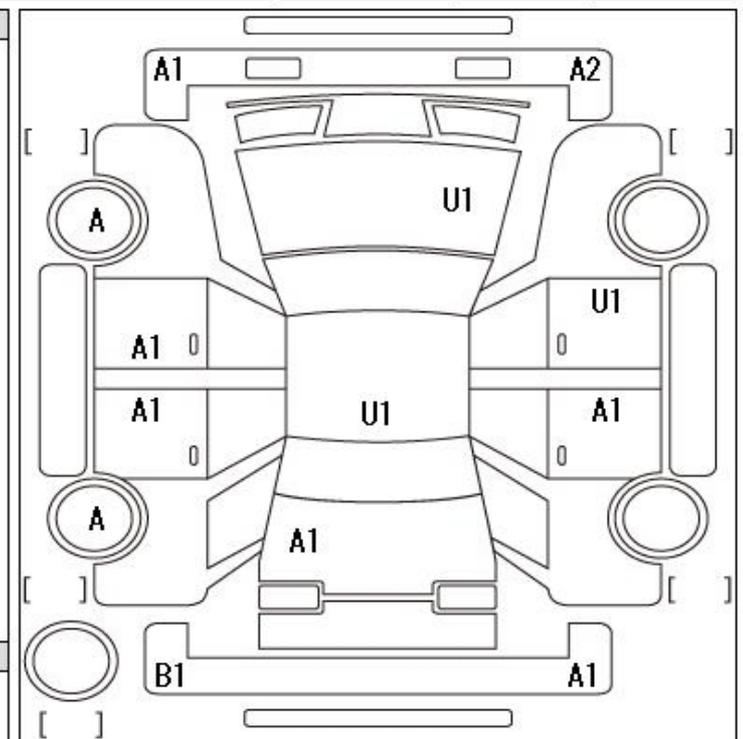
検査員記入欄
室内薄汚れ 外装うすい線傷 サイドガーニッシュ下A バッテリーあがり
事務局よりご案内

A:転 U:欠 B:転を伴う欠 P:要塗装 W:補修箇 S:錆 C:腐食、穴 G:凹陥点検 XX:交換済み X:要交換 欠:欠品 内・外装評価 5段階5段階順(A・B・C・D・E) 2

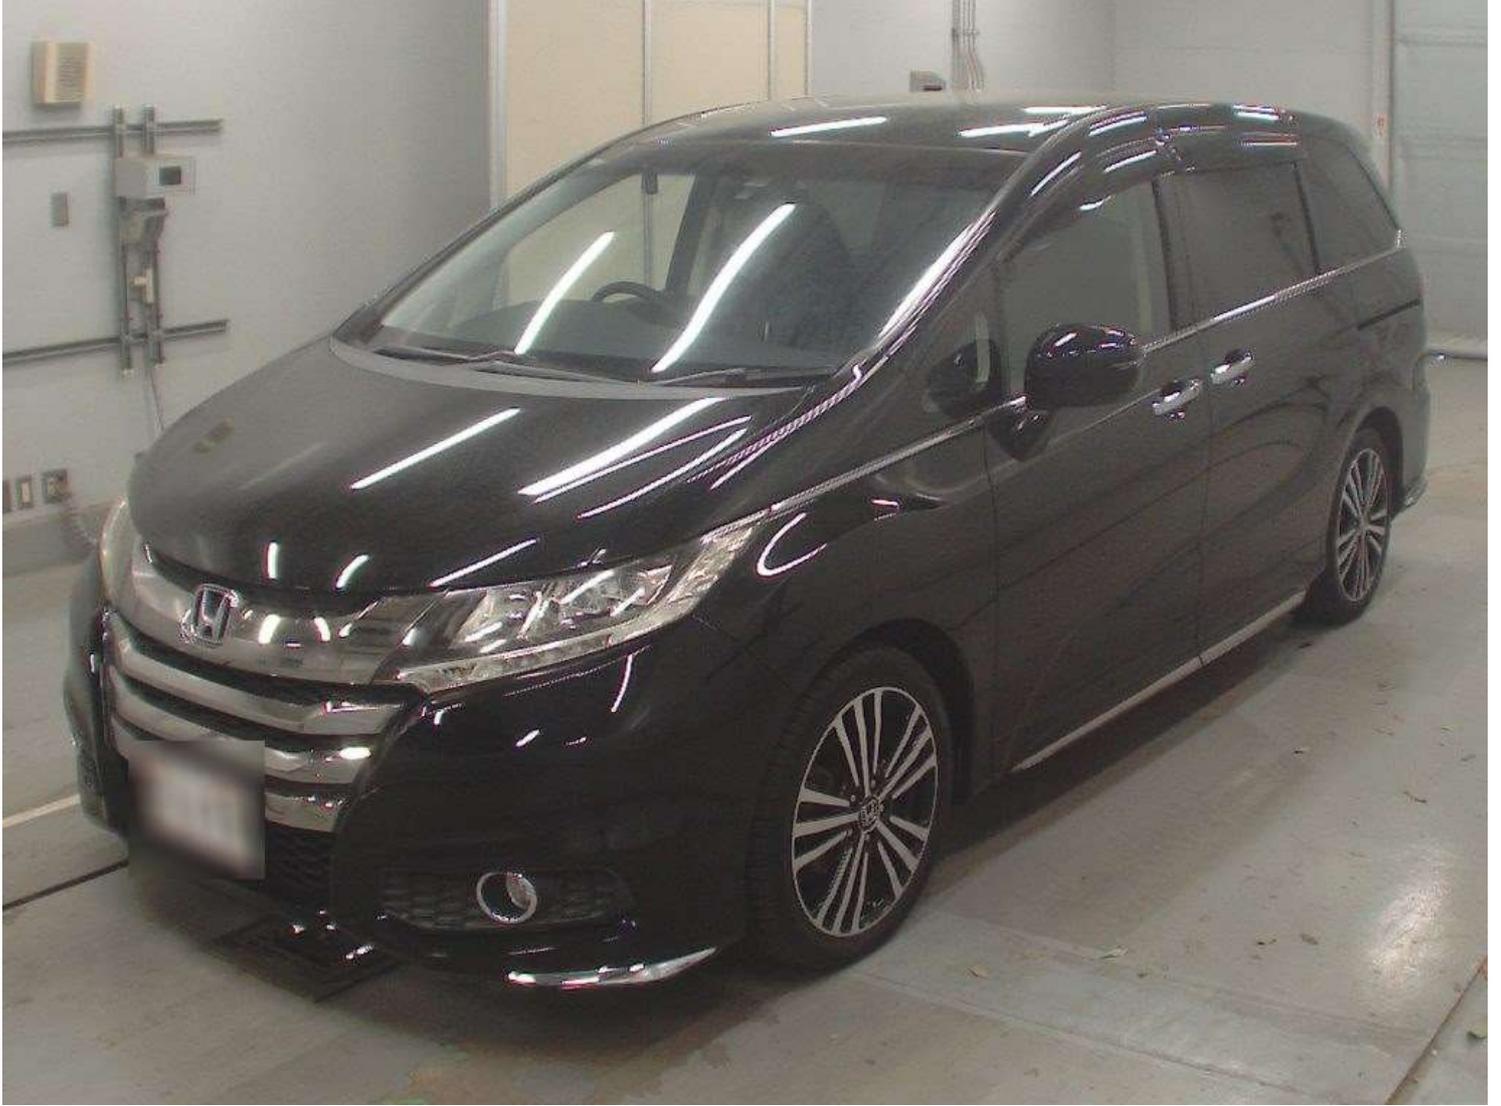
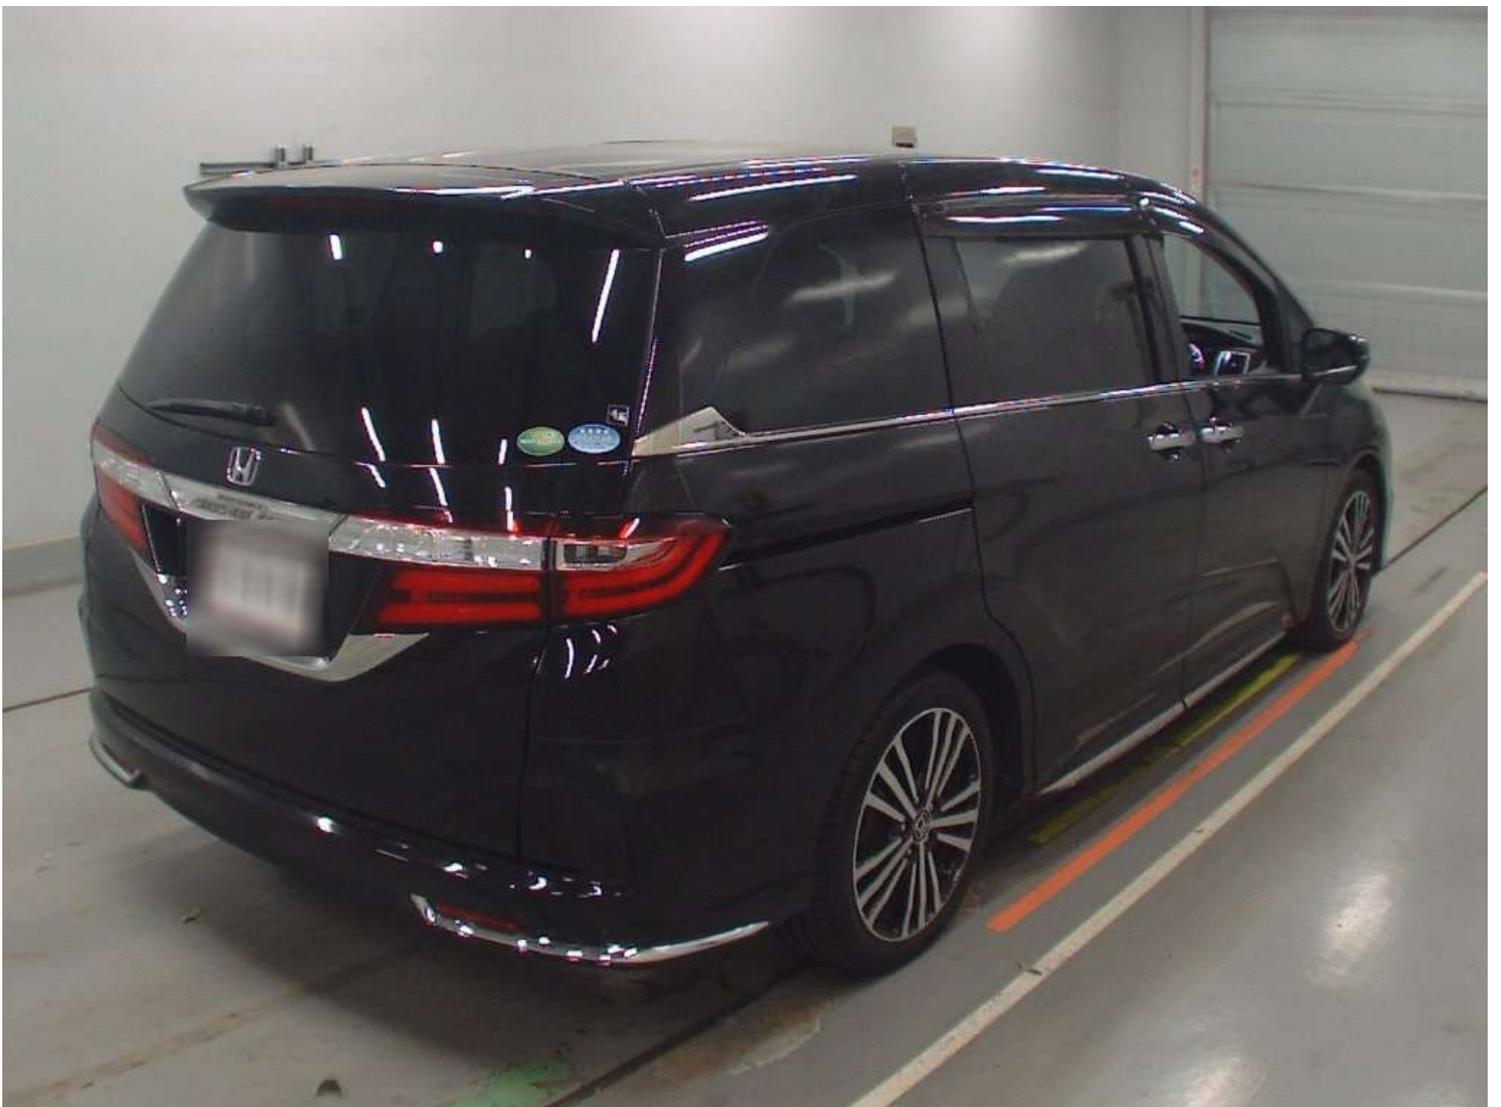
出品番号	初度登録	車名	ドア形状	グレード	評価点
30329	H25	オデッセイ	5W	アブソルート	4
初出品	年	車歴	排気量	燃料	型式
	12月	自家用	2400cc	ガソリン	DBA-RC1
					外装 内装
					C B
