Vehicle History Report

Chassis number ¹: WVVZZZ1KZBW058906

Make: VOLKSWAGEN

Model: GOLF

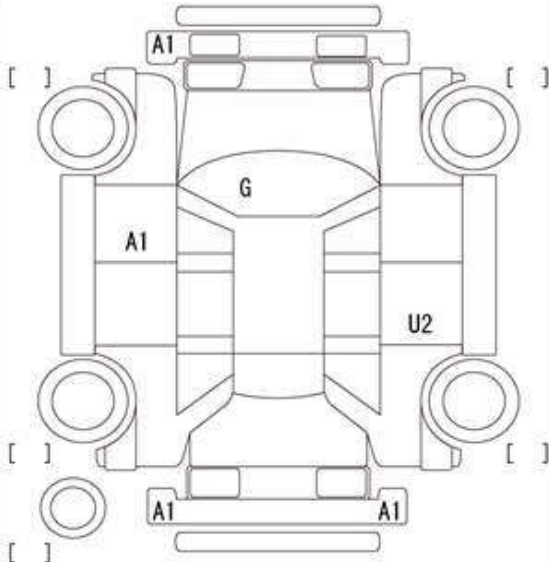
セールスポイント	特記事項・不具合箇所

<p>A (ネズ)・U (ヘコミ)・B (ネズを伴うヘコミ)・W (補修跡)・P (要塗装) R (錆)・C (腐食)・X (交換済み)・X (要交換)・G (ガラス点キズ)</p>
★クルーズコントロール ★地デジ	天張はがれ大 室内薄汚れ 外装小傷有り	
注意事項

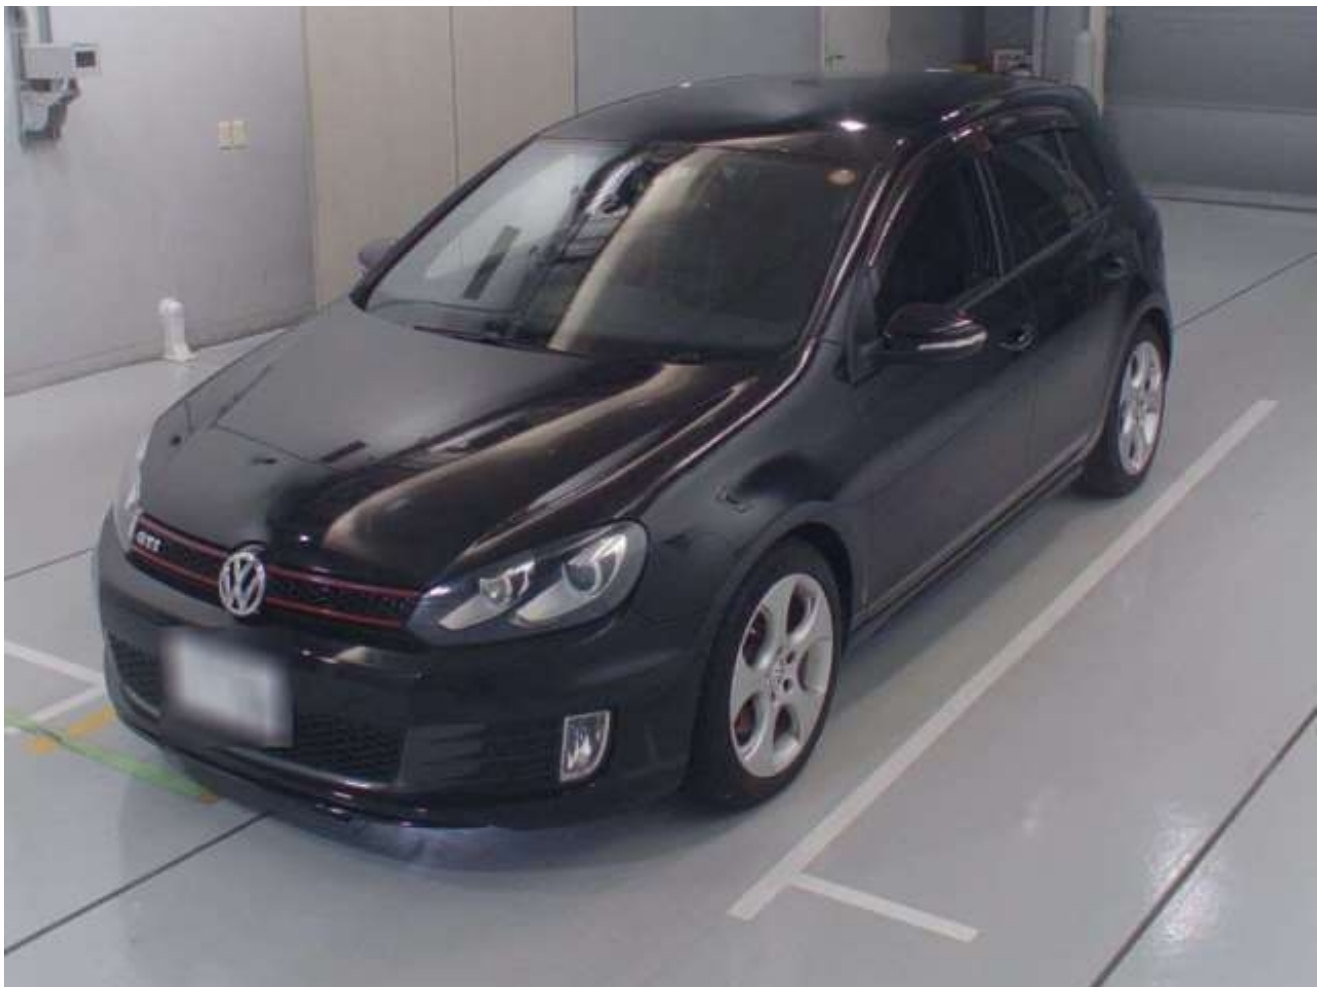
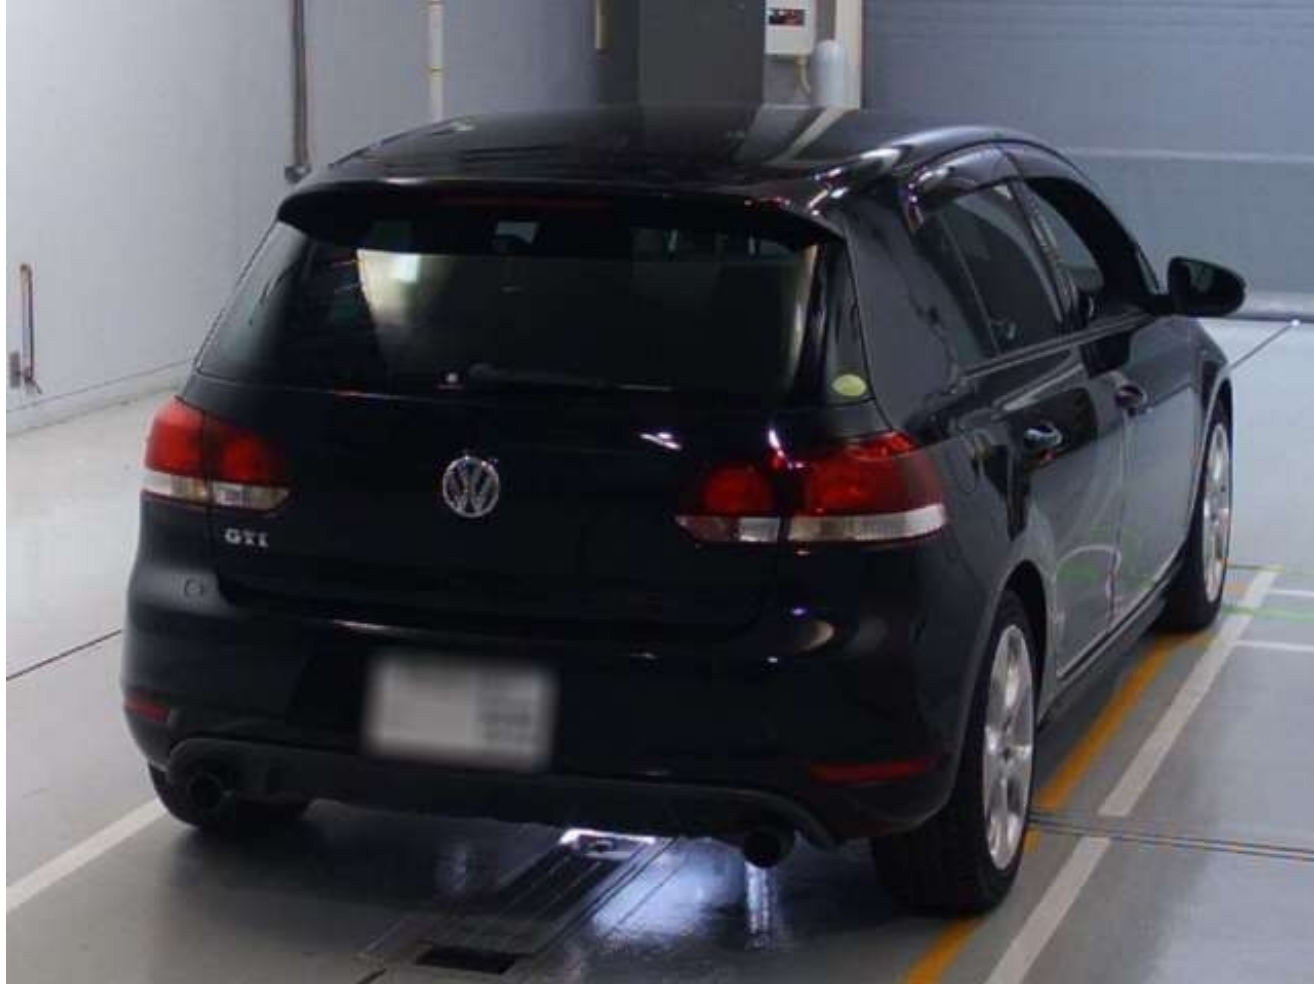
輸入車プライムコーナー

58304	車種 (自動車以外は記入) 排気量	2000	型式	ABA-1KCCZ	評価点
	初年度年 月 車名	22/12月 ゴルフ	駆動方式 グレード	2WD GTI	4
	内装		4WD	6

車検	5年12月	ソフト	FAT	時高	SR	AW	PS	RV	
走行	63,140 km	冷房	AAC	セールスポイント	カワ	TV	ナビ	ETC	
外色	黒	色種		有・無	7インチ TV Bluetooth				
燃料	ガソリン	内装色		HID, ETC					
輸入年	元	区	号	外18インチ

リサイクル料	18990円	登録税	名	307	て	5735
関税		車台	WVWZZZ	KZB	058906	
○注意事項 (登録 不具合箇所および故障等)
