Vehicle History Report

Chassis number [1]:	RC1-1000322
Manufacture date:	2013-10-14
Make:	HONDA
Model:	ODYSSEY
Body:	DBA-RC1
Grade:	ABSOLUTE EX
Engine:	K24W
Drive:	2WD
Transmission:	AT

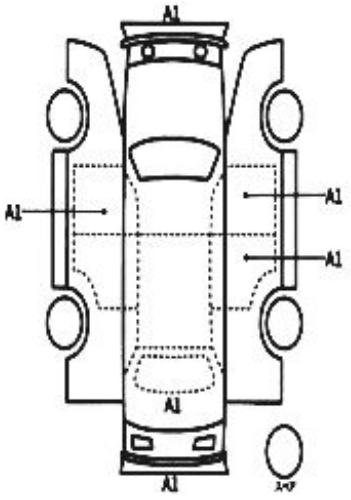
リヤワイパーアーム欠品

ルーム内一部汚れキズ

小キズ小凹

外装くすみ
