# Vehicle History Report

**Chassis number <sup>1</sup>:** ANH20-8047112

**Model:** VELLFIRE

**Grade:** 2.4Z

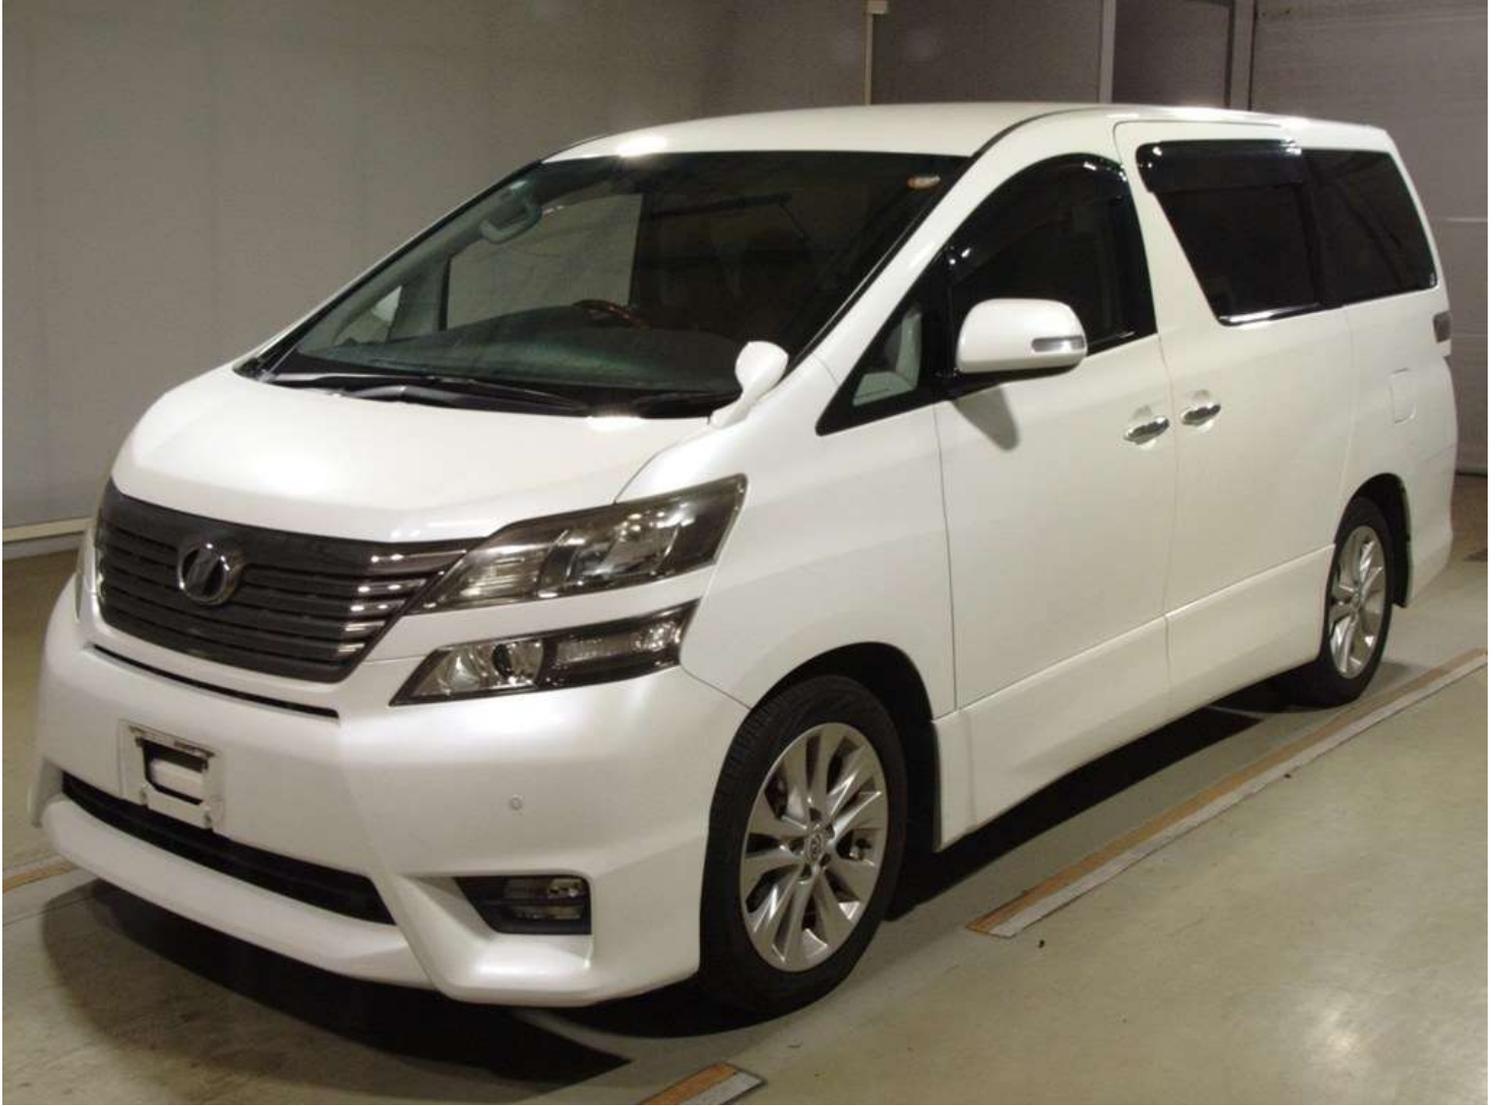
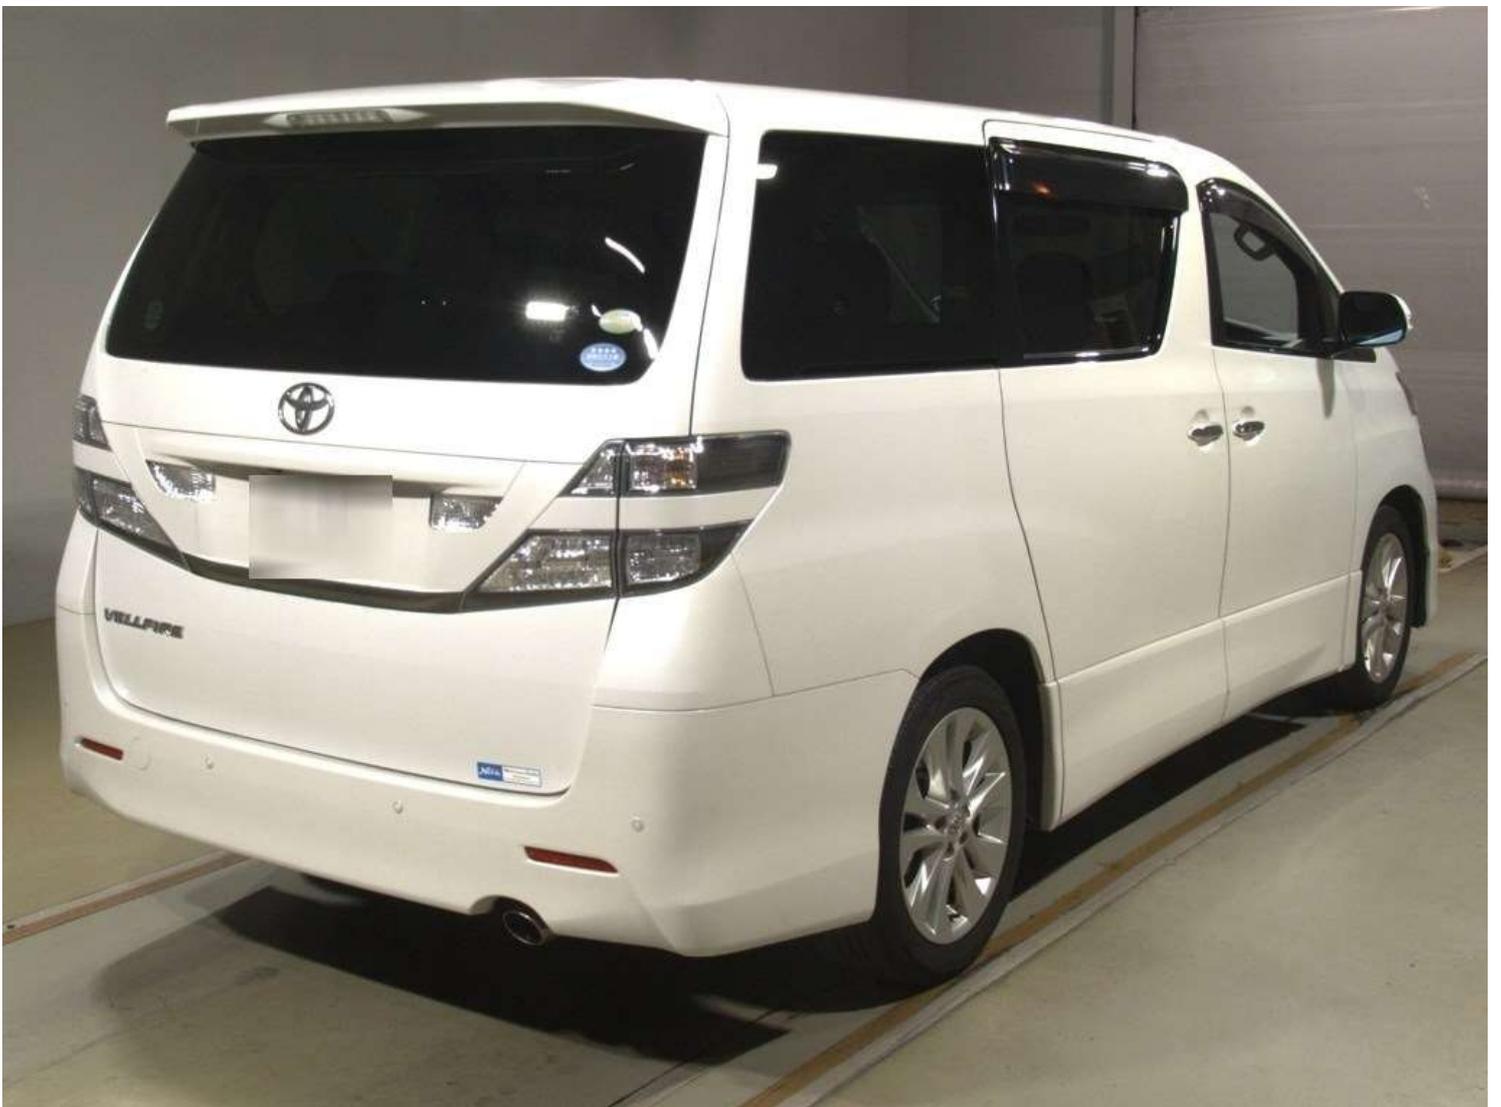
# グリーン①コーナー

30233	車種(自動車には記入) 排気量		型式		評価点
	2400		DBA-ANH20W		
初年度登録年月	車名	排気量	グレード	駆動	内装 B
H21/3月	トヨタ ヴェルファイア	5D	2.4Z	2WD	
車検	年月日	シフト	IAT	燃費	SR (燃費) PS (ナビ) 内 (エア)
走行	80,900 km	冷房	AAC	セールスポイント	
外色	パール	カラー	070	HID・ETC	
燃料	ガソリン	内装色		パワースライドドア	
輸入車		輸入車		ナビ・DTV・バックカメラ	
		ハンドル		スマートキー	
		月	日	プッシュスタート	
リサイクル	18,290円	乗車定員	8人	登録地	
○注意事項(事故・不具合箇所および故障等)				車台	ANH20-8047112
				シリアル
