VEHICLE DETAILS

Chassis number ¹: Z12-110772

Make: NISSAN

Model: CUBE

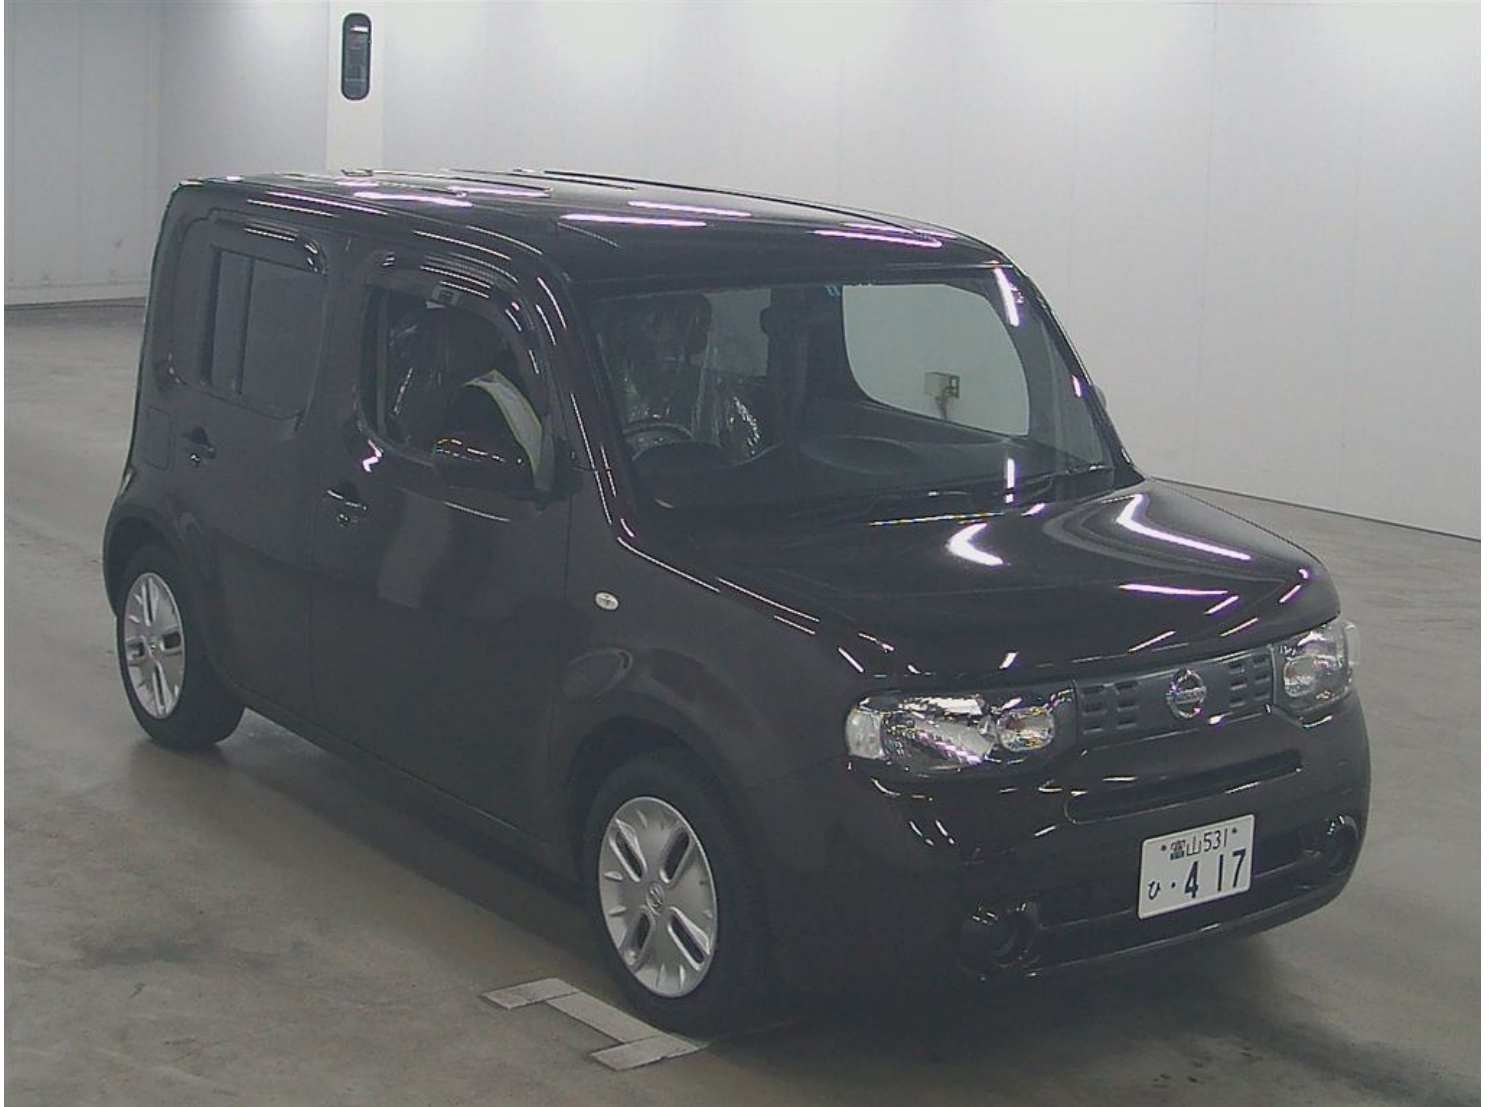
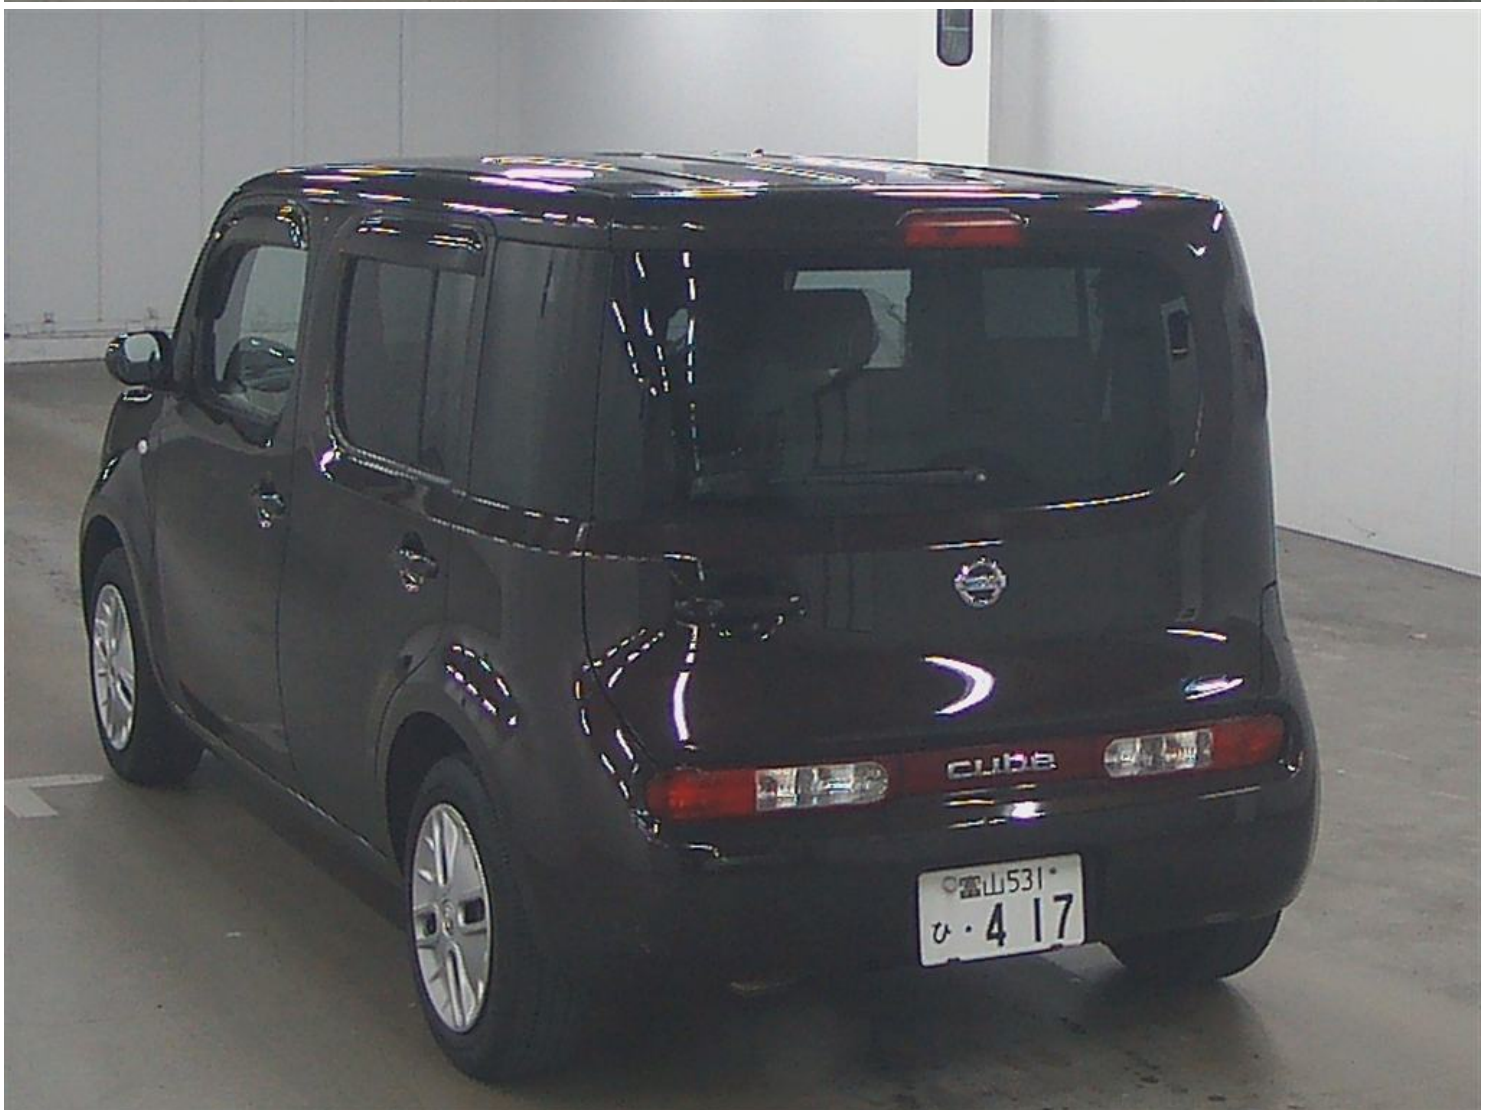
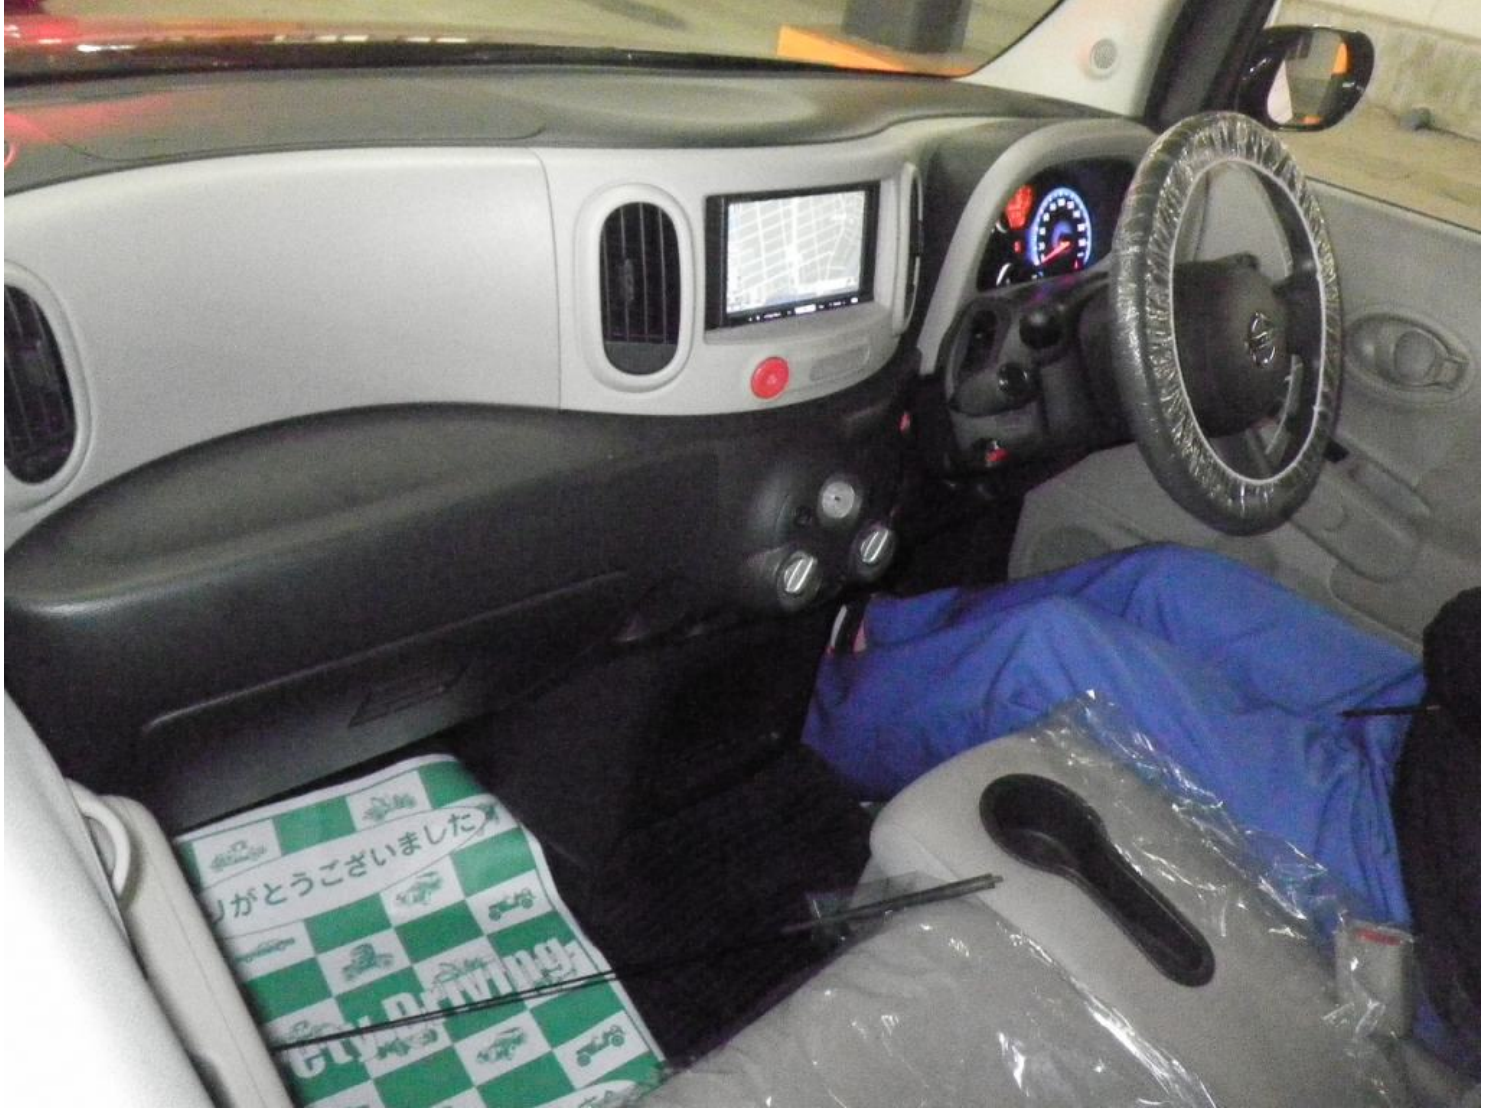
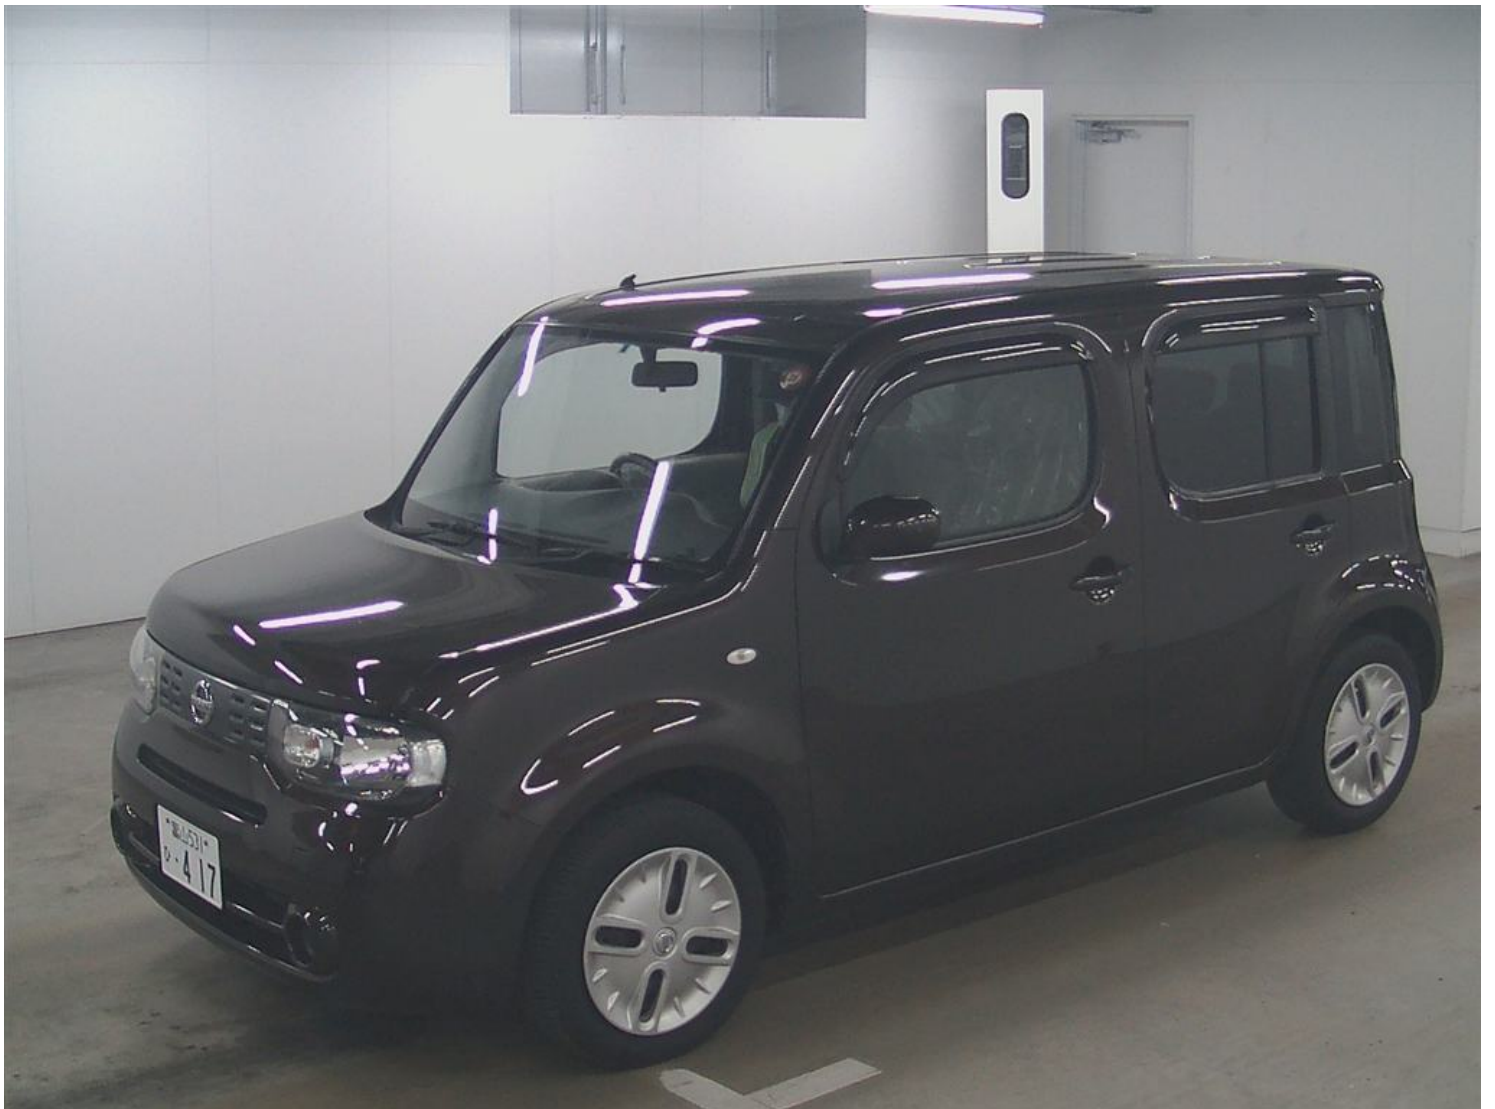
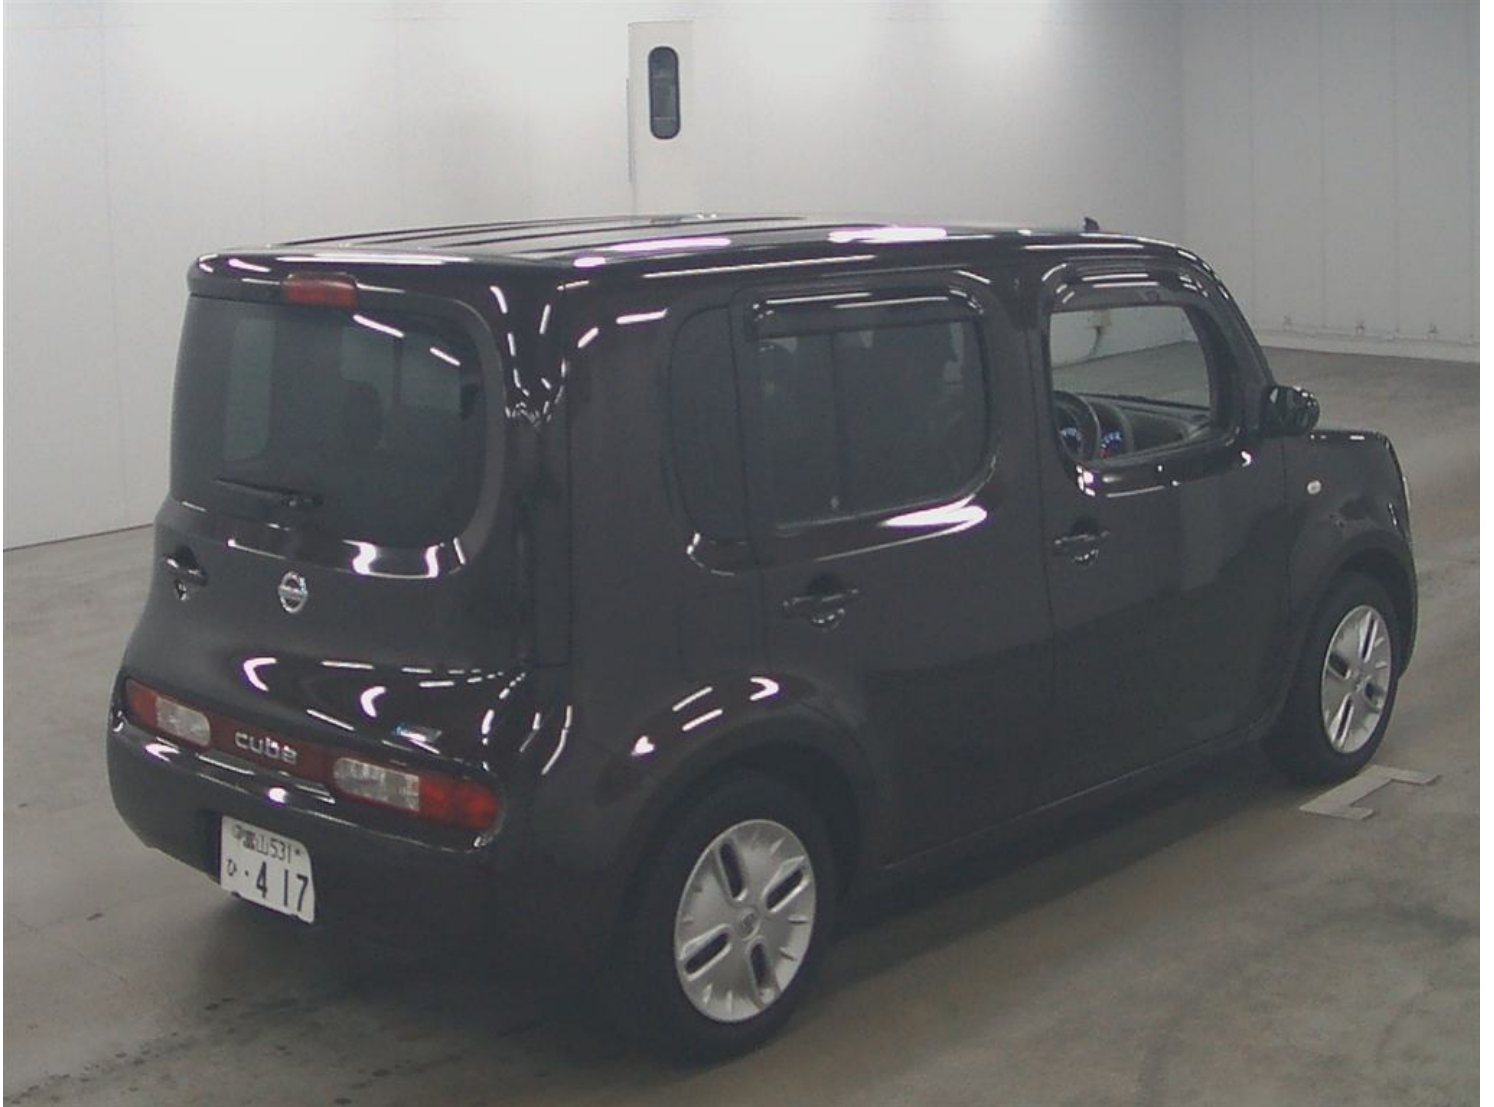
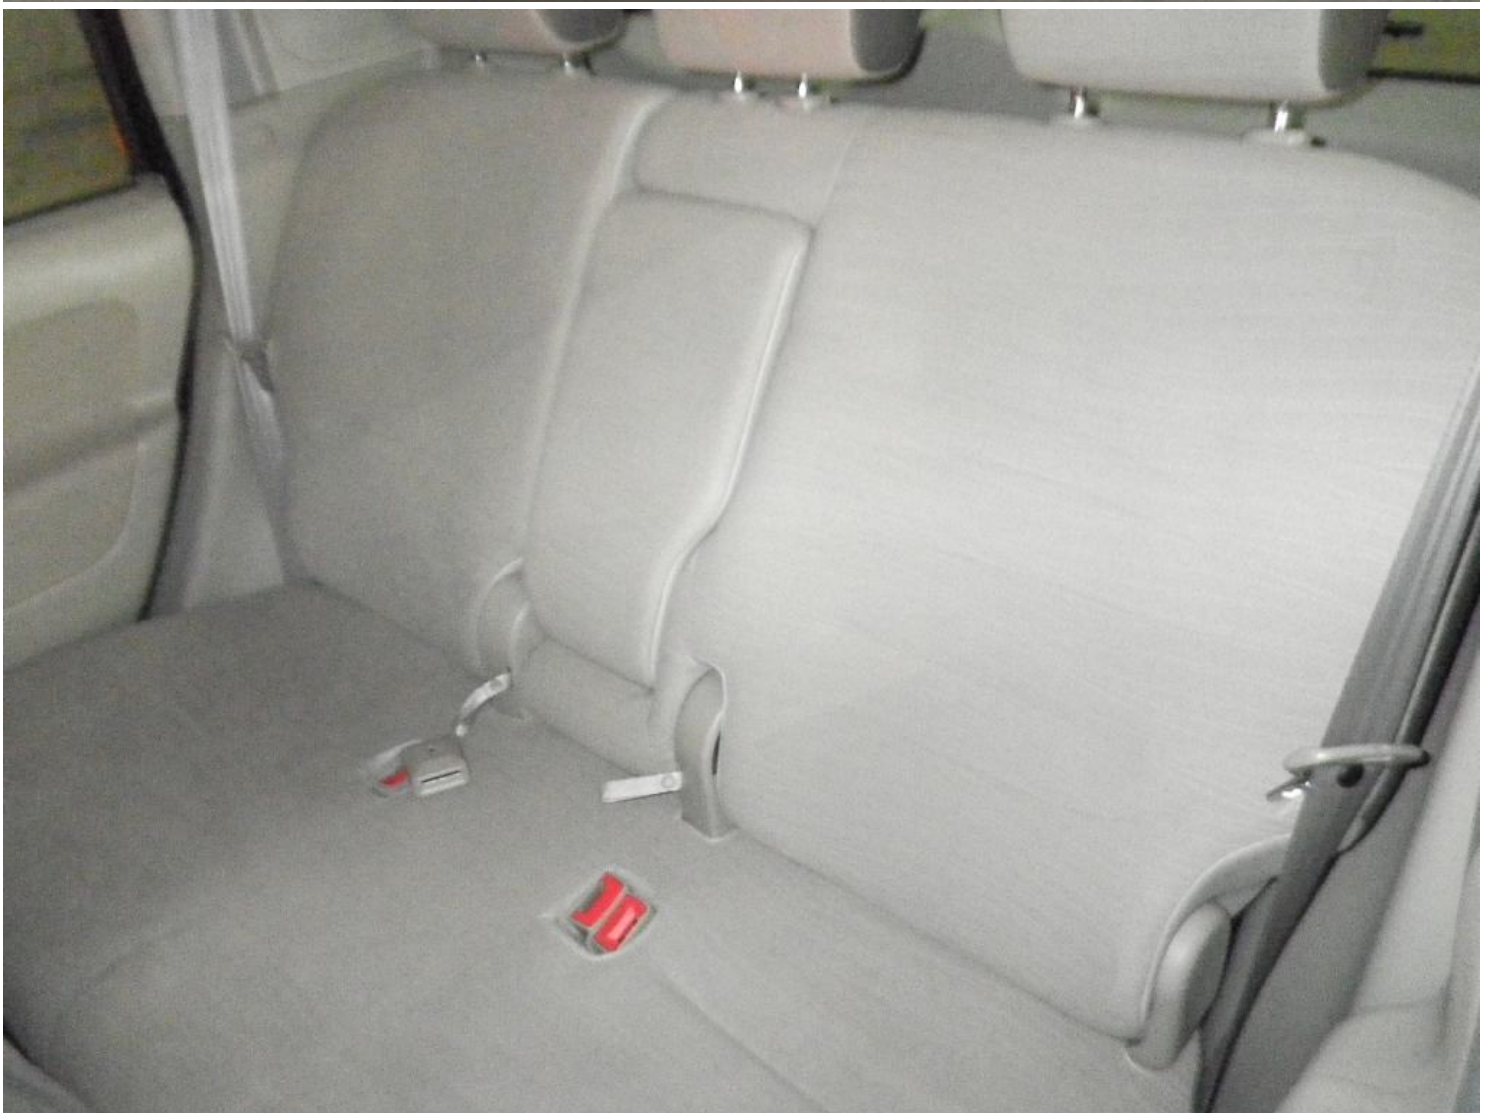
出品番号 [2062] 8133	初度登録年月 22 8 月		車名・グレード キューブ 15X Mセレクション			2WD 4WD	評価点 4
	型式 DBA-Z12		排気量 1,500 cc	ドア 5 形状 HB	定員 5 積載	ディーラー・並行 モデル年式 年 ハンドル 左・右	外装 内装 <<
車歴 自家用・()			シフト CAT		セールスポイント (正常に機能するものに限ります) ★ユーザー買取車★		
車検 5 年 8 月(21日)			冷房 AC		装備品 (純正品に限り○をつけてください) 新車保証書 <input checked="" type="checkbox"/> PS <input checked="" type="checkbox"/> PW <input checked="" type="checkbox"/> ABS <input checked="" type="checkbox"/> エアB AW <input checked="" type="checkbox"/> 有 無 <input type="checkbox"/> SR <input type="checkbox"/> ナビ <input type="checkbox"/> TV <input type="checkbox"/> カワ		
走行 12万5千998 km		燃料 ガソリン 軽油					
色 ブラウン		色替 色コード L50		R券 9,820 円 名変期限 月 日			
注意事項申告欄 (不具合内容等は具体的に記入して下さい)

修復歴 有 [箇所]

検査員 FW キズ・飛石・ヒビ割・リペア跡・×要
 記入欄 内装 キズ・汚損・コゲ・穴・ズレ・キレ・破れ

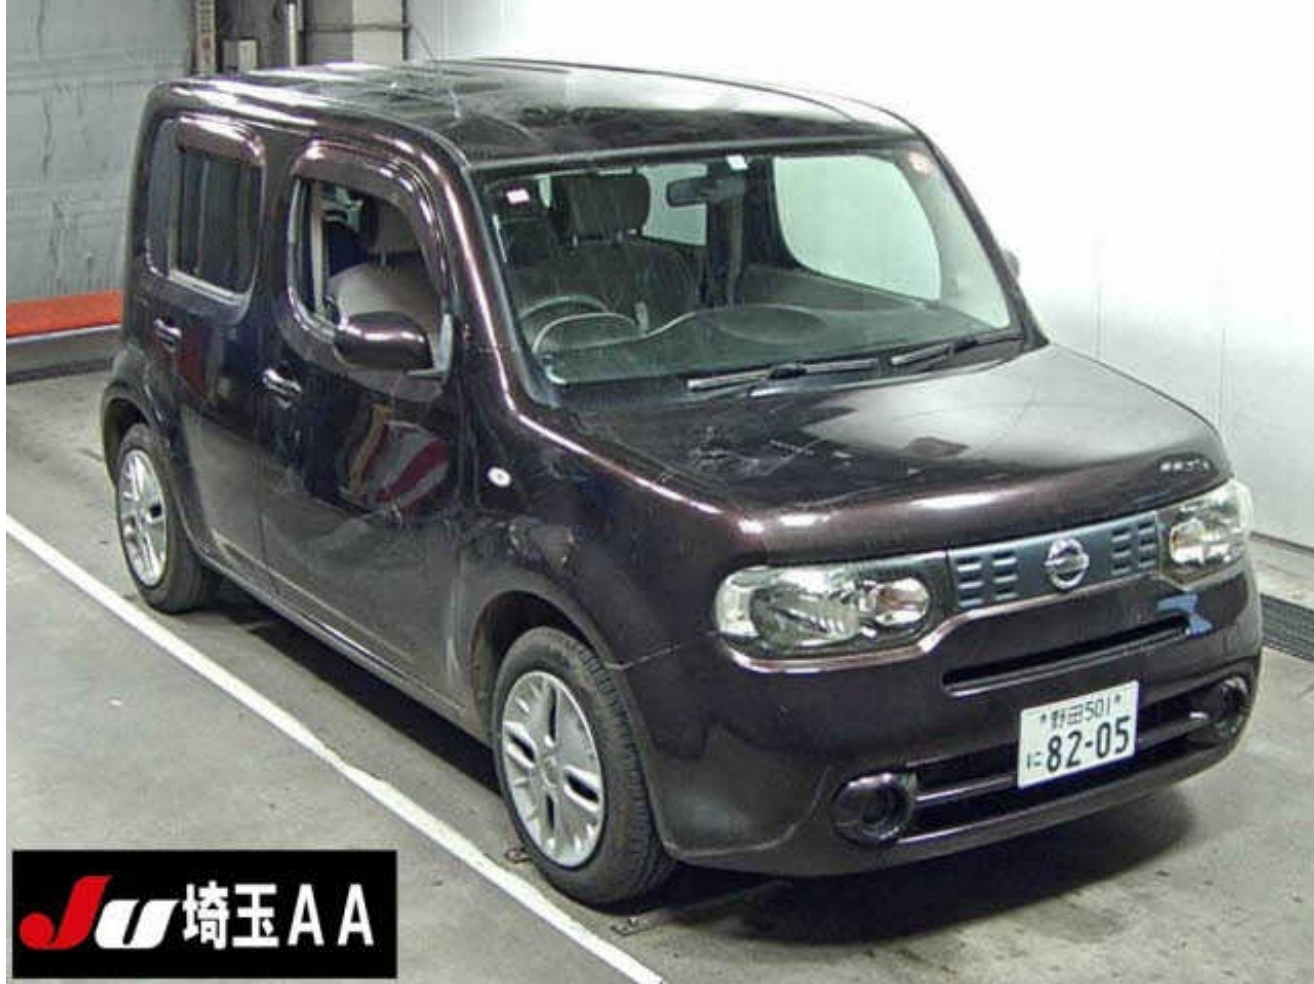
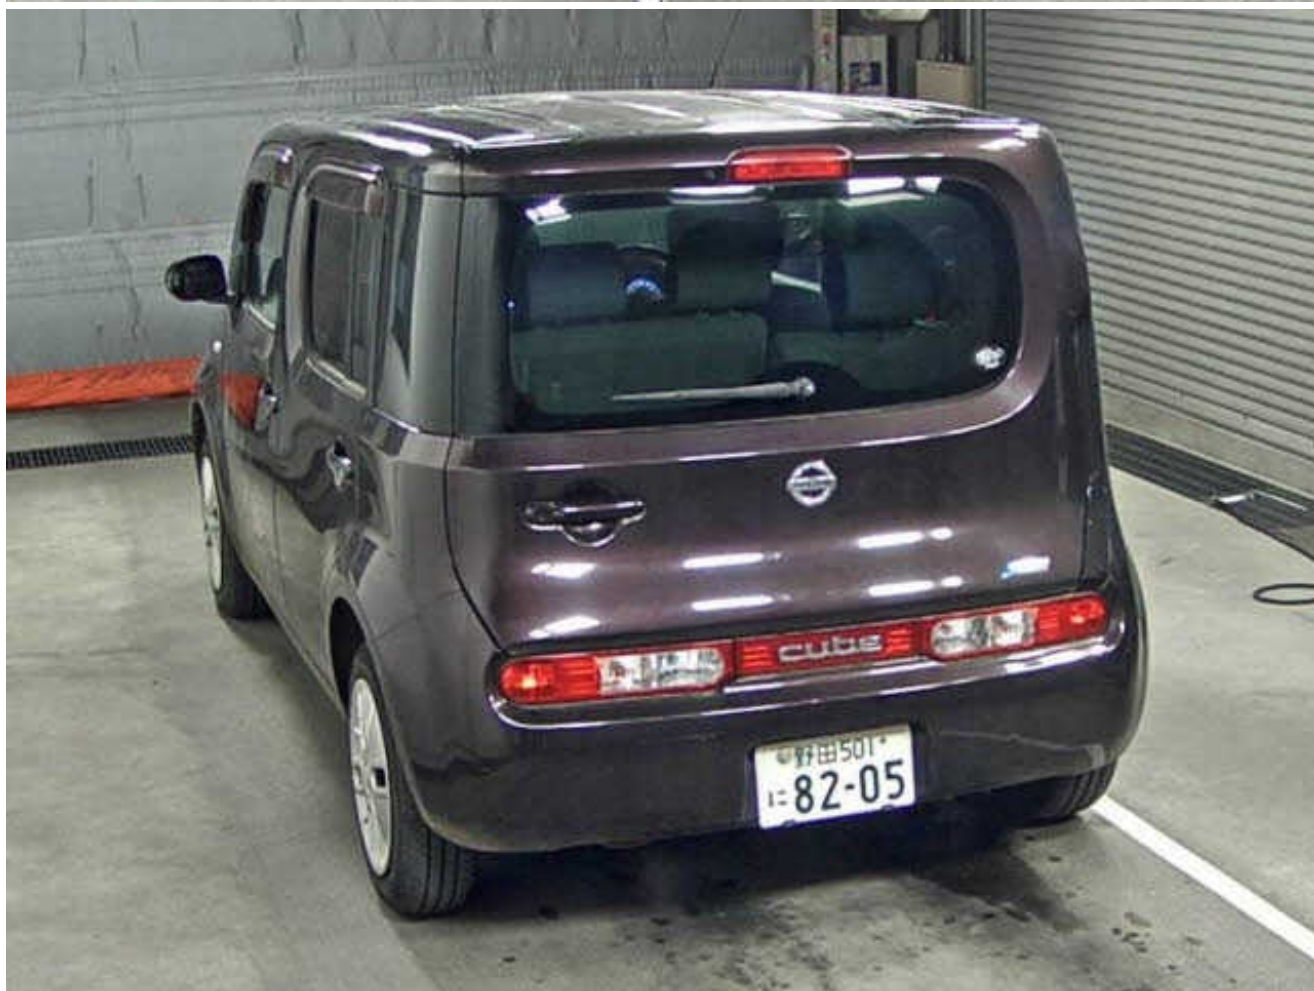
車台番号	Z12-110772			A-キズ E-エクボ U-凹み W-補修跡 S-サビ C-腐食 XX-交換済							
登録番号	野田	501	に	820	5	型式指定番号 参考	16207	種別区分番号 参考	0029		
		車庫証明用 参考	長さ	389	cm	幅	169	cm	高さ	165	cm
