## VEHICLE DETAILS

**Chassis number <sup>1</sup>:** WVVZZZ6RZBY311707

**Make:** VOLKSWAGEN

**Model:** POLO

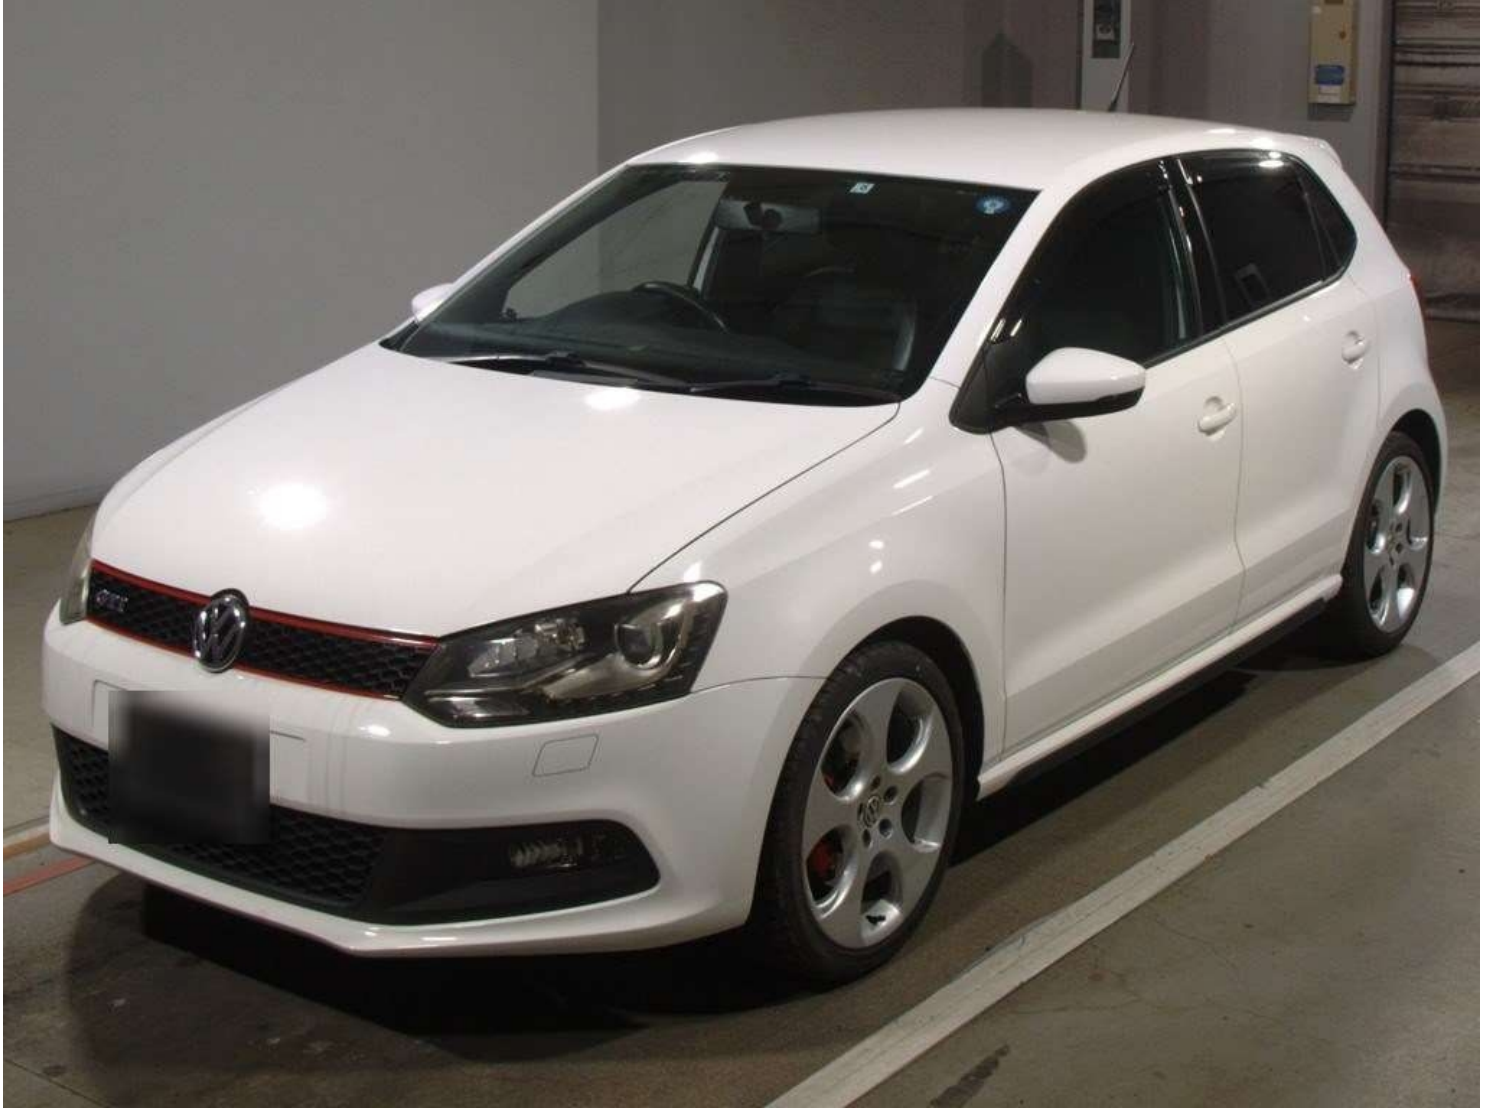
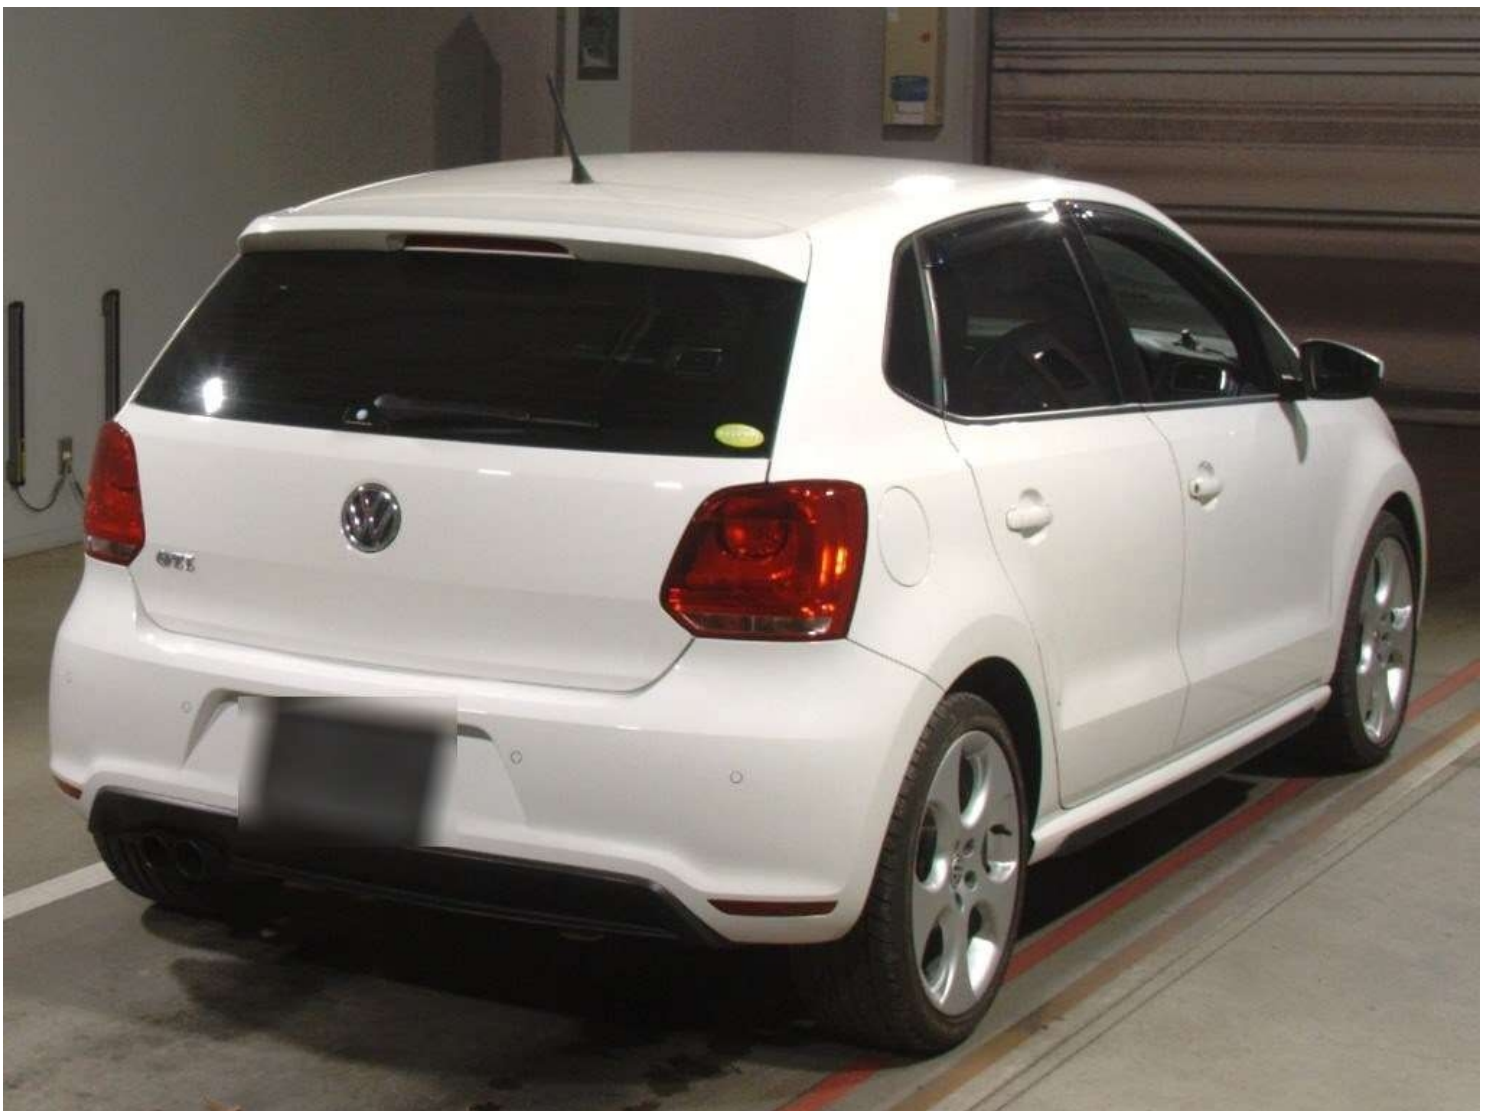
| ABS・スリップ表示灯点灯<br>空気圧警告灯点灯<br>シート切れ・破れ小<br>室内動物の毛<br>ダッシュ板のり付<br>タッチP跡<br>バンパー下A<br>ガラスフィルム張 |

A: 欠\* U: 欠\* B: 欠\* を伴う欠\* P: 要塗装 W: 補修跡 S: 錆 C: 腐食 G: 7D以外\* 欠点欠\* XX: 交換済み X: 要交換 内・外装評価 5段階評価(A・B・C・D・E) 1
