Vehicle History Report

Chassis number ¹: TE52-015820

Make: NISSAN

Model: ELGRAND

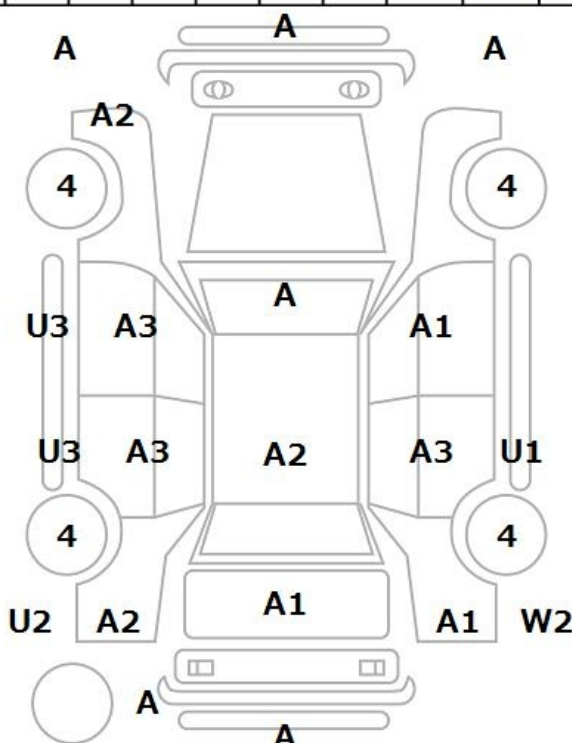
| 出品No. 1155 | | | | | | | | | | | |

| ダッシュボード割れ ハンドルスレ 車内汚れ シートヘタリ エンドパネル歪み FグリルPハゲ A/Tショック 天張シミ プロテクターキズ | | | | | | | | | | | |
