Vehicle History Report

Chassis number ¹: ANH20-8193109

Make: TOYOTA

Model: VELLFIRE

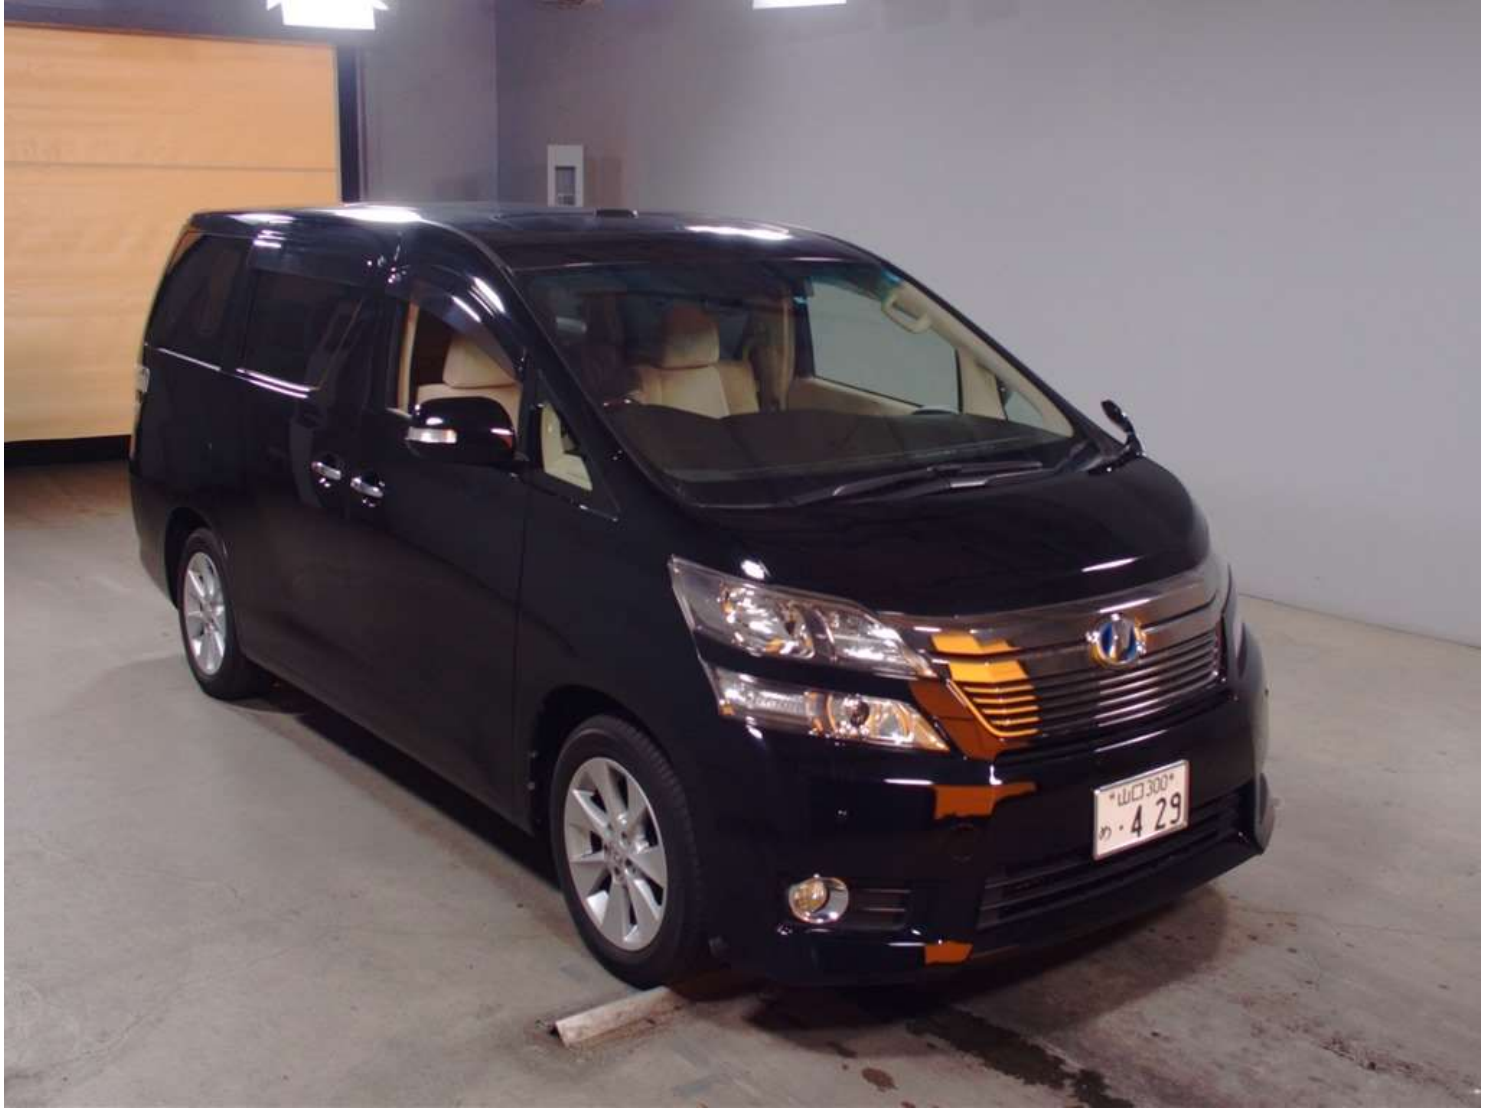
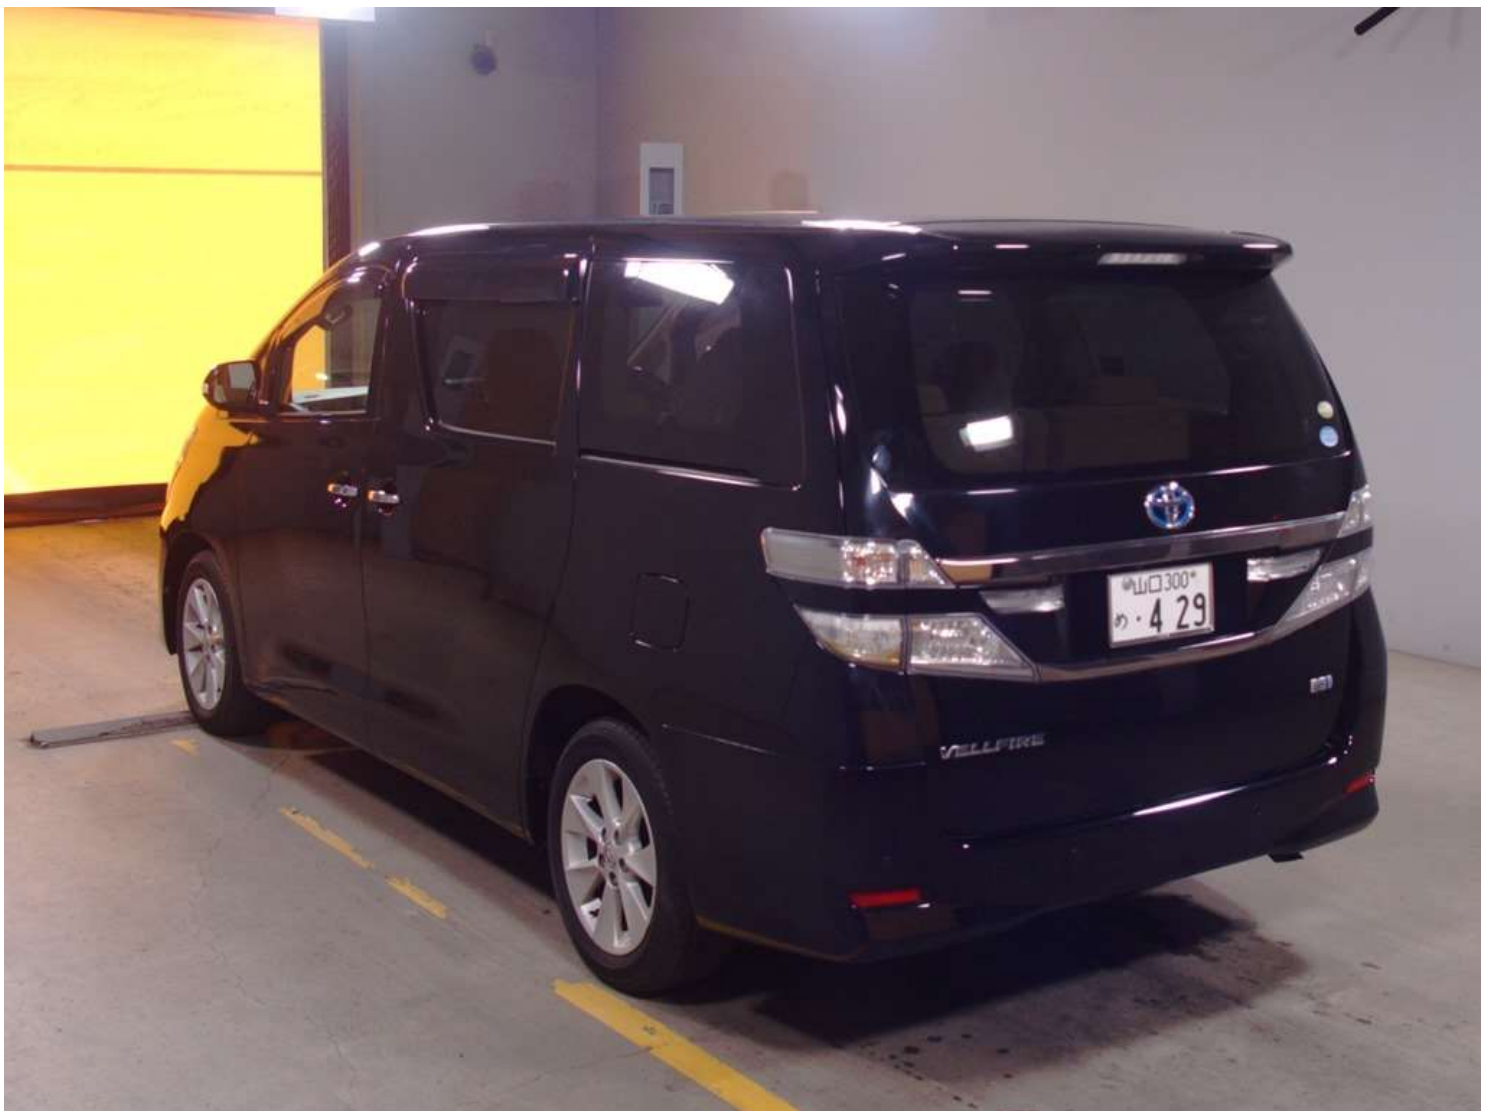
出品番号	初度登録	車名	ドア形状	グレード	評価点
33026	H 23年	ヴェルファイア	5W	2.4V	3.5
		車歴	排気量	燃料	
	12月	自家用	2400 cc	ガソリン	DBA-ANH20W
					外装 内装
					D C

検査員記入欄
室内汚れ タッチP跡 外装小傷有り ローダウン 社外アルミホイール
事務局よりご案内

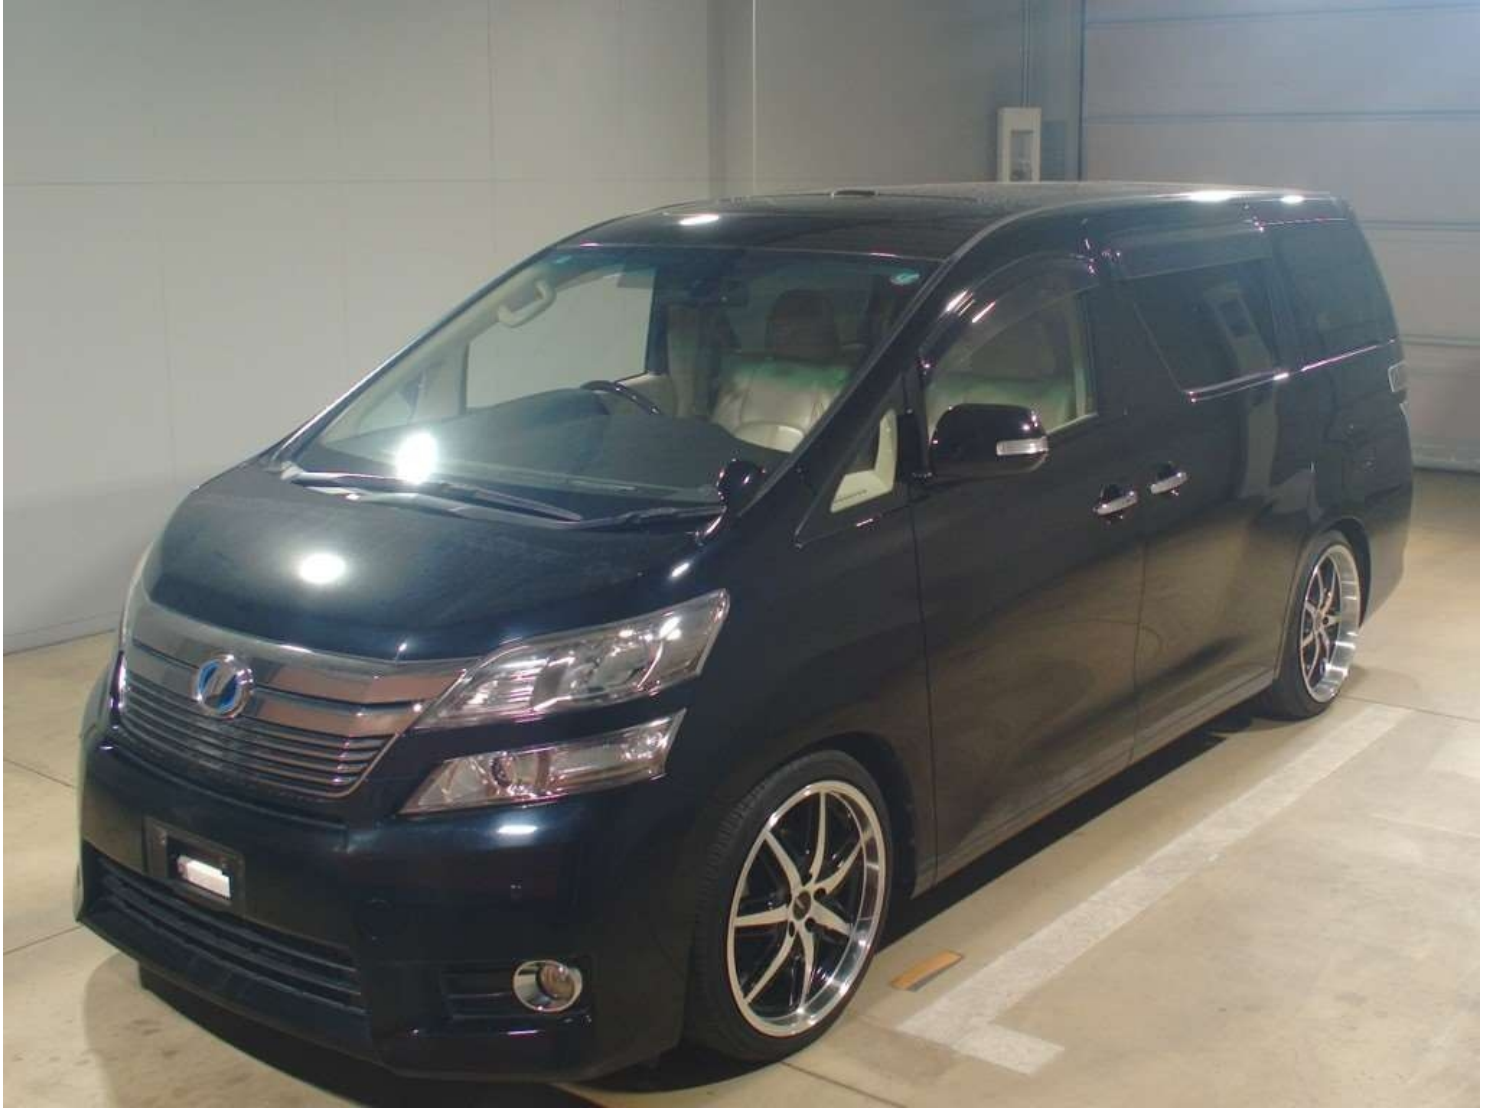
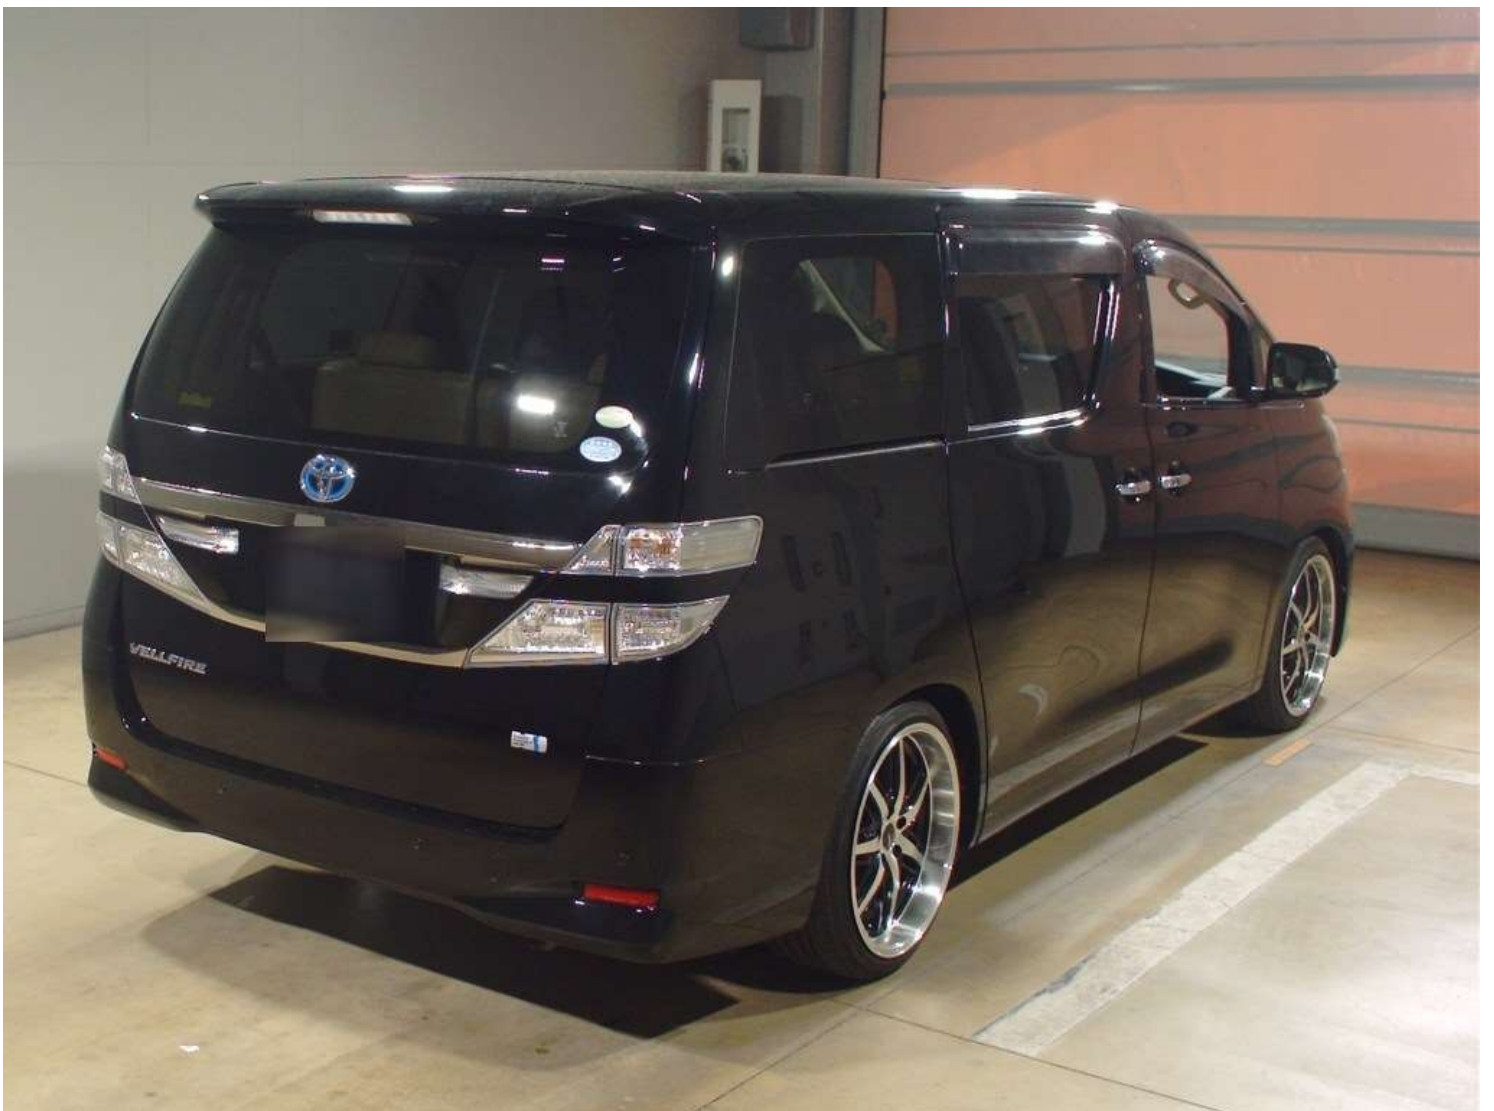
20079	車種 (型式) (輸入)	排気量	型式	年式												
		2400	DBA-ANH20W	4.5												
	初年度登録年月	車名	グレード	駆動												
	H23/12月	トヨタ	50	2WD												
		ヴェルファイア	2.4V													
<table border="1"> <tr> <td>シフト</td> <td>IAT</td> <td>SA</td> <td>MA</td> <td>PS</td> <td>PA</td> </tr> <tr> <td></td> <td></td> <td>カワ</td> <td>TV</td> <td>ナビ</td> <td>エア</td> </tr> </table>					シフト	IAT	SA	MA	PS	PA			カワ	TV	ナビ	エア
シフト	IAT	SA	MA	PS	PA											
		カワ	TV	ナビ	エア											
車検 年月日		走行	冷房	AAC	セールスポイント											
		73,760 km			サンルーフ											
外色	色番	カラー	純正8インチナビ・TV 純正フリップダウンモニター HIDヘッドライト スマートキー&プッシュスタート													
クロ	-	202														
燃料	ガソリン	内装色														
車検	輸入区分	ハンドル														
リサイクル	16,360円	8人														
○注意事項 (※後・不具合修理および点検時)			原台地	ANH20-8193109												
			シリアル地

- 外ホイールキズ
- ハンドルノブスレ
- トリムキズ汚れ シートカバー取付
- 各キズ凹

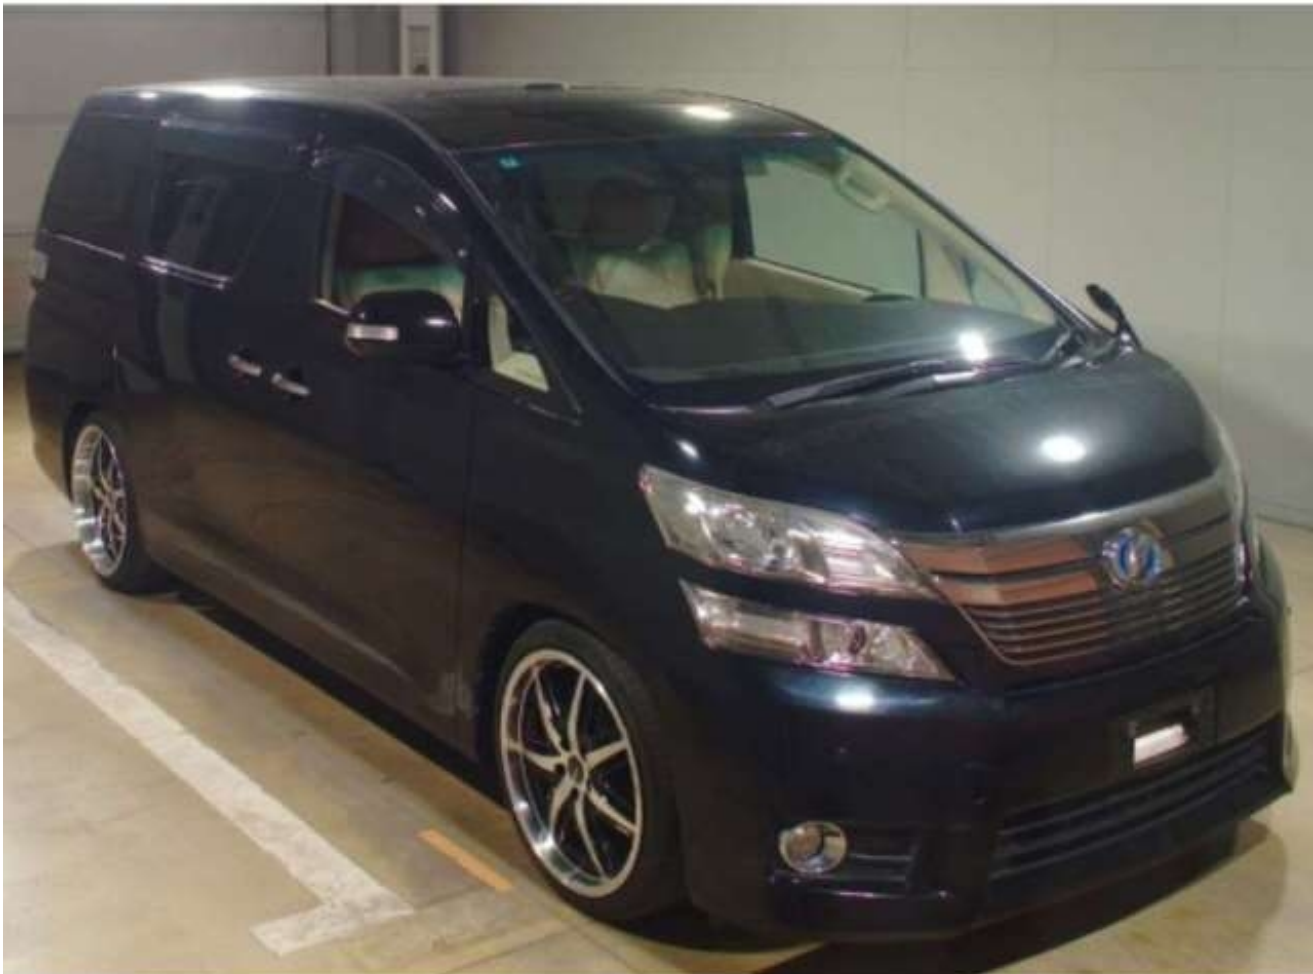
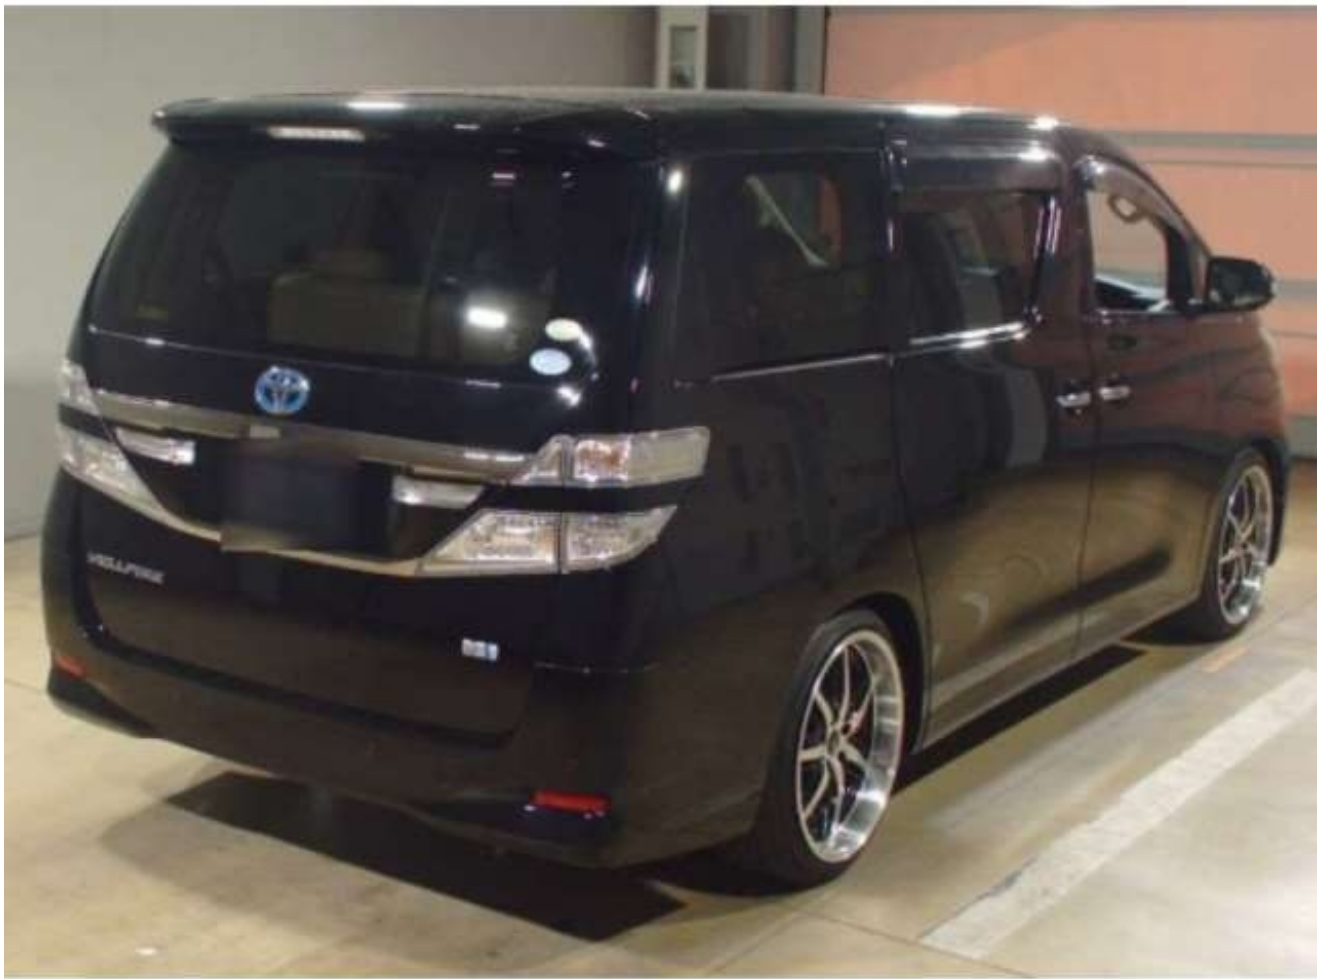
初年度登録	車名	ドア形式	グレード	駆動	総合評価						
23.12月	ヴェルファイア	5-W	2.4V		4						
型式	排気量	燃料	車種	定員(最大)	積載量(最大)	輸入車					
DBA ANH20W	2,400 _{CC}	ガソリン	自家用	8名	Kg	車種別					
ミッション	エアコン	カラー	外装色	PS	PW	17B	ABS	SR	保証書	取扱	内装評価
IAT	AAC	202	クロ	ナビ	TV						B
走行距離	車検	登録ナンバー	注か設備	車台番号	積込金						
73,760 _{km}				ANH20-8193109	16,360 _円

セールスポイント	特記事項・不具合箇所
<ul style="list-style-type: none"> ★サンルーフ ★純正8インチナビ・TV ★純正フリップダウンモニター ★HIDヘッドライト ★スマートキー&プッシュスタート 	車内汚れ ANキズ ウスキズ・小凹
注意事項
